Memorandum from the Chairman to the Members of the Committee on Education and Labor

Regarding the August 2007 Disaster at the
Crandall Canyon Mine

May 8, 2008
Congressman George Miller, Chairman

3717-CRANDALL CANYON MINE
ROOF CONTROL PLAN REVIEW
US HOUSE COMMITTEE ON EDUCATION AND LABOR

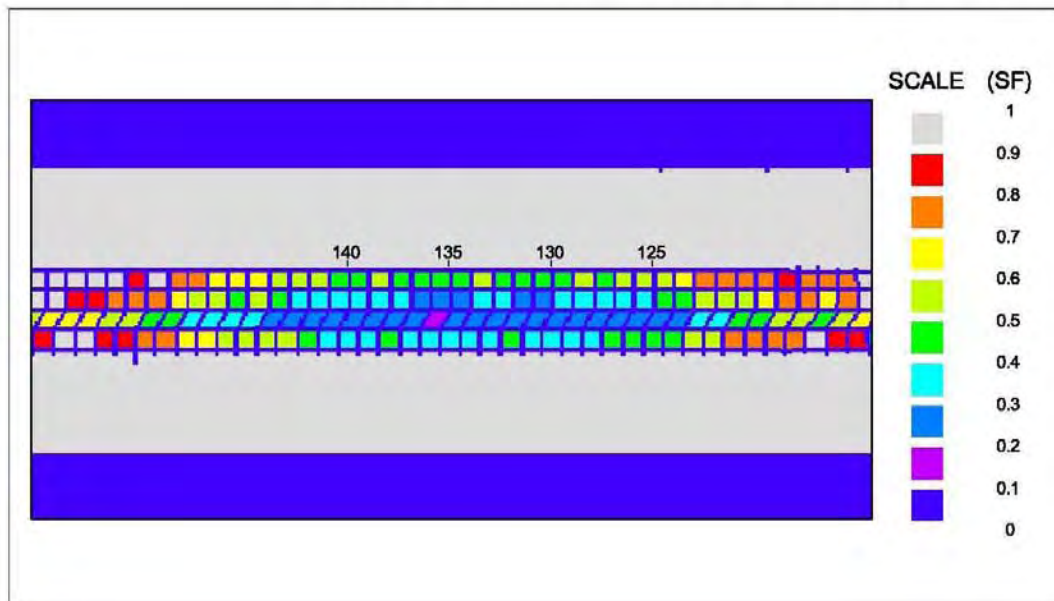
Figure T.3 Base Case Pillar Strain SF - Main West (LaModel)

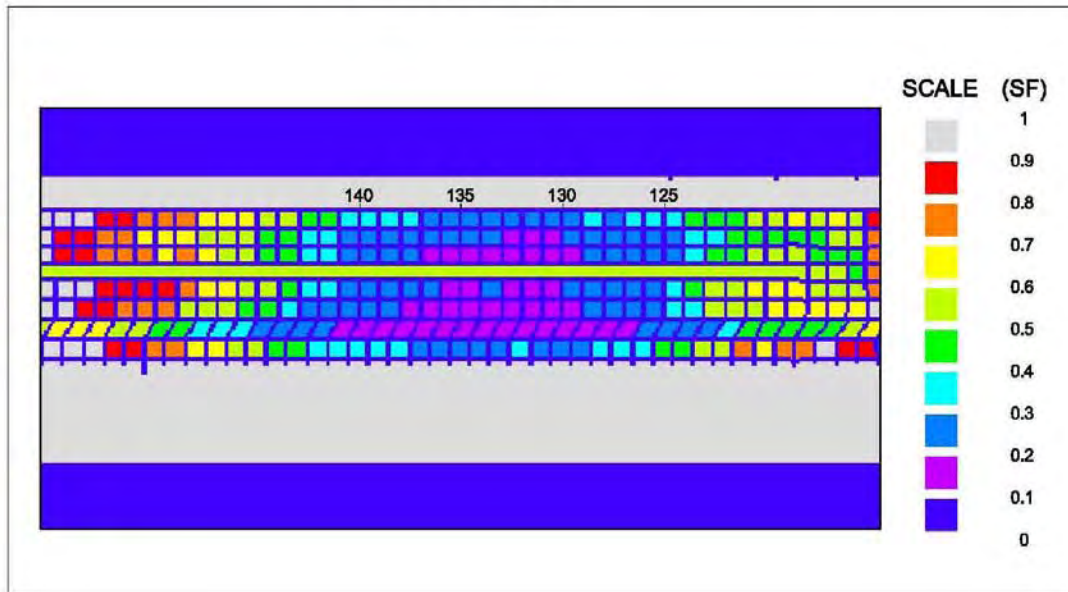
Figure T.4 Base Case Pillar Strain SF - Main West and North Barrier (LaModel)

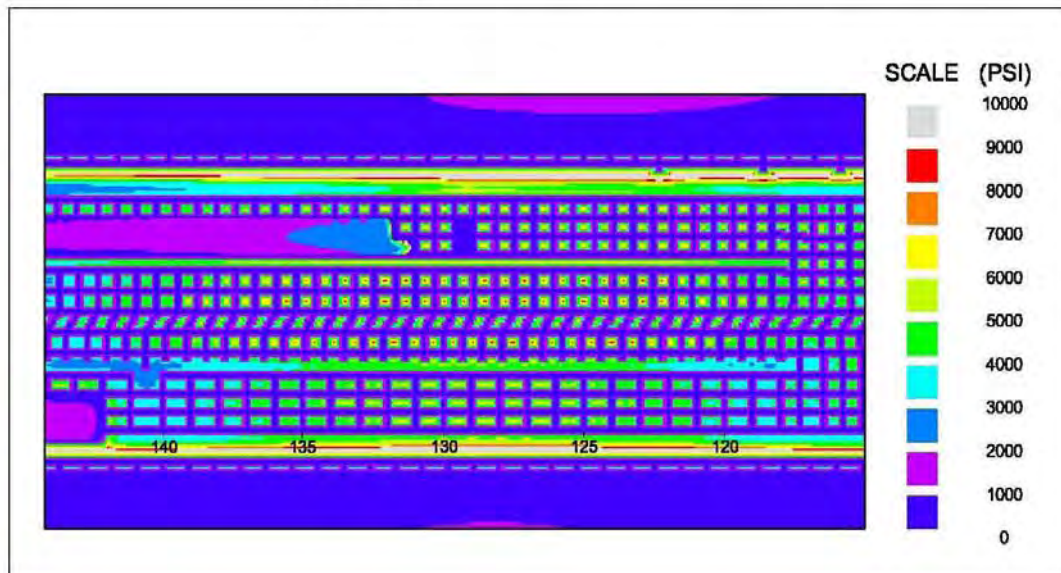
Figure T.5 Base Case Vertical Stress - South Barrier Retreat (LaModel)

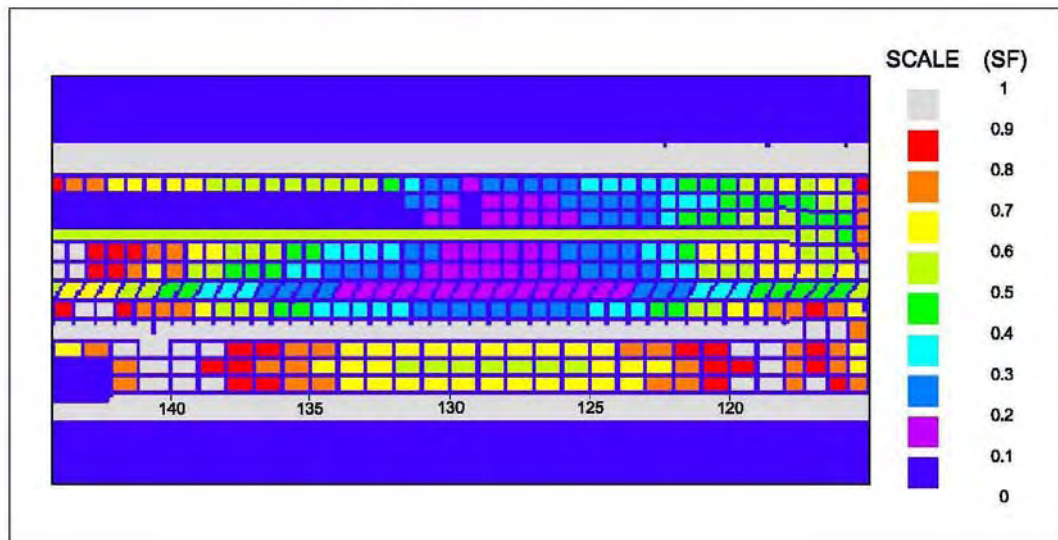
Figure T.6 Base Case Pillar Strain SF - South Barrier Retreat (LaModel)

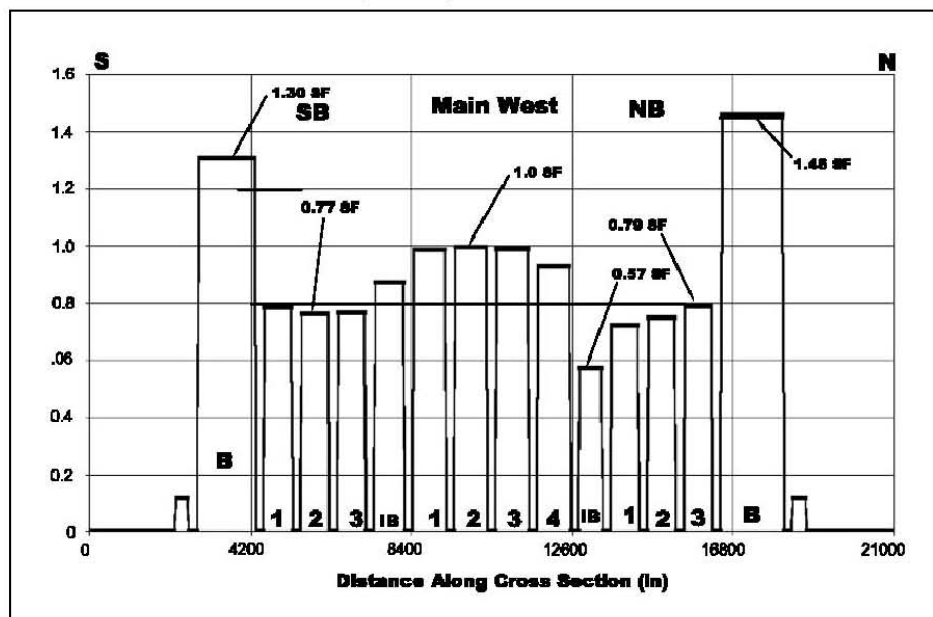
Figure T.7 Strain SF Main West - North Barrier and South Barrier (LaM2D)

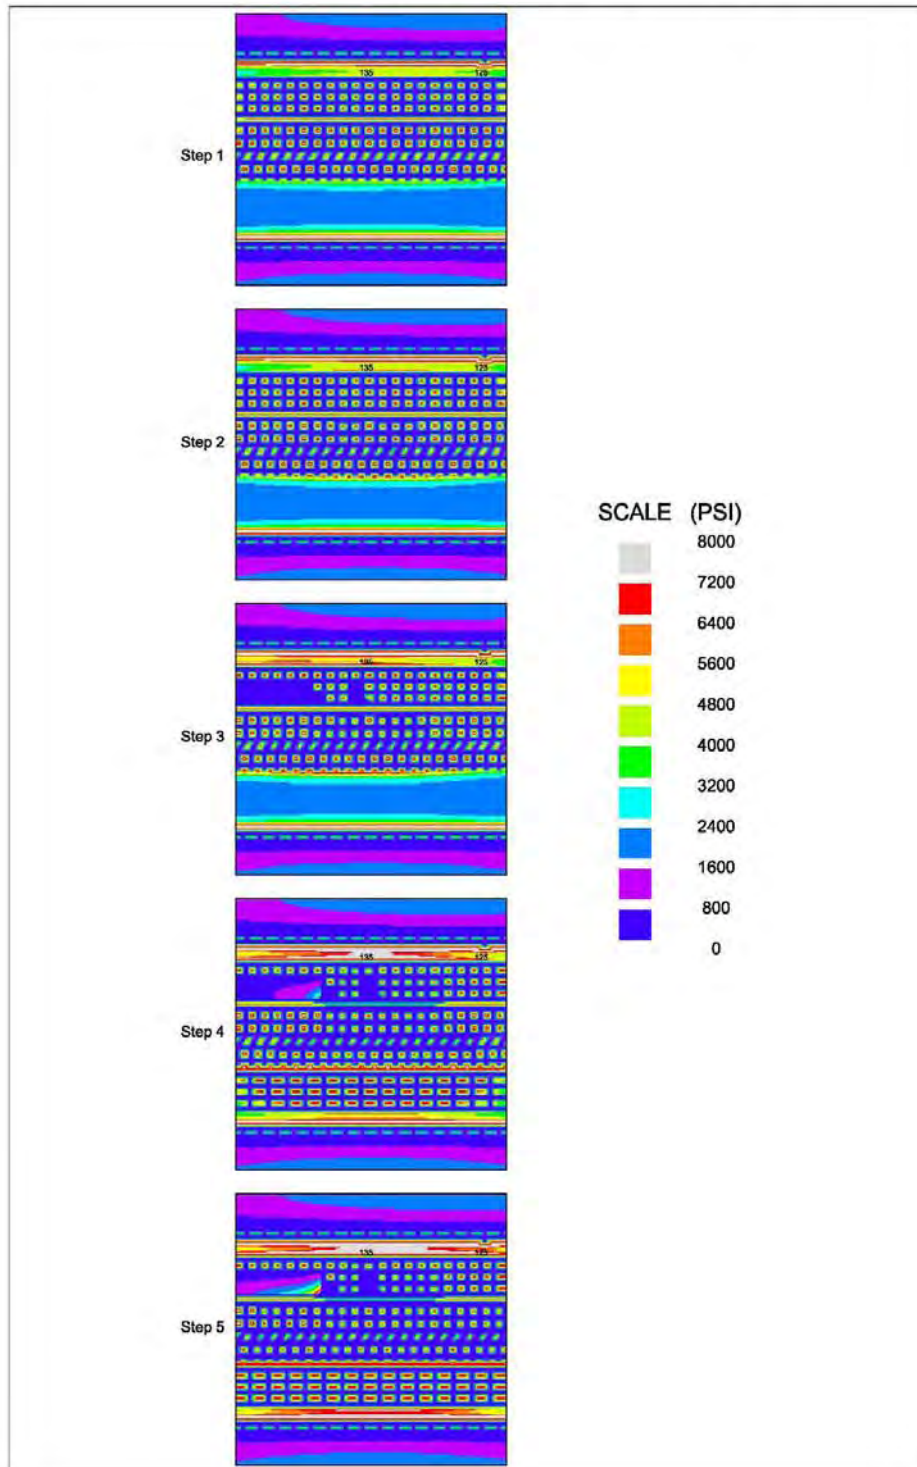
Figure T.8 Five Step Damage Sequence – Vertical Stress (LaModel)

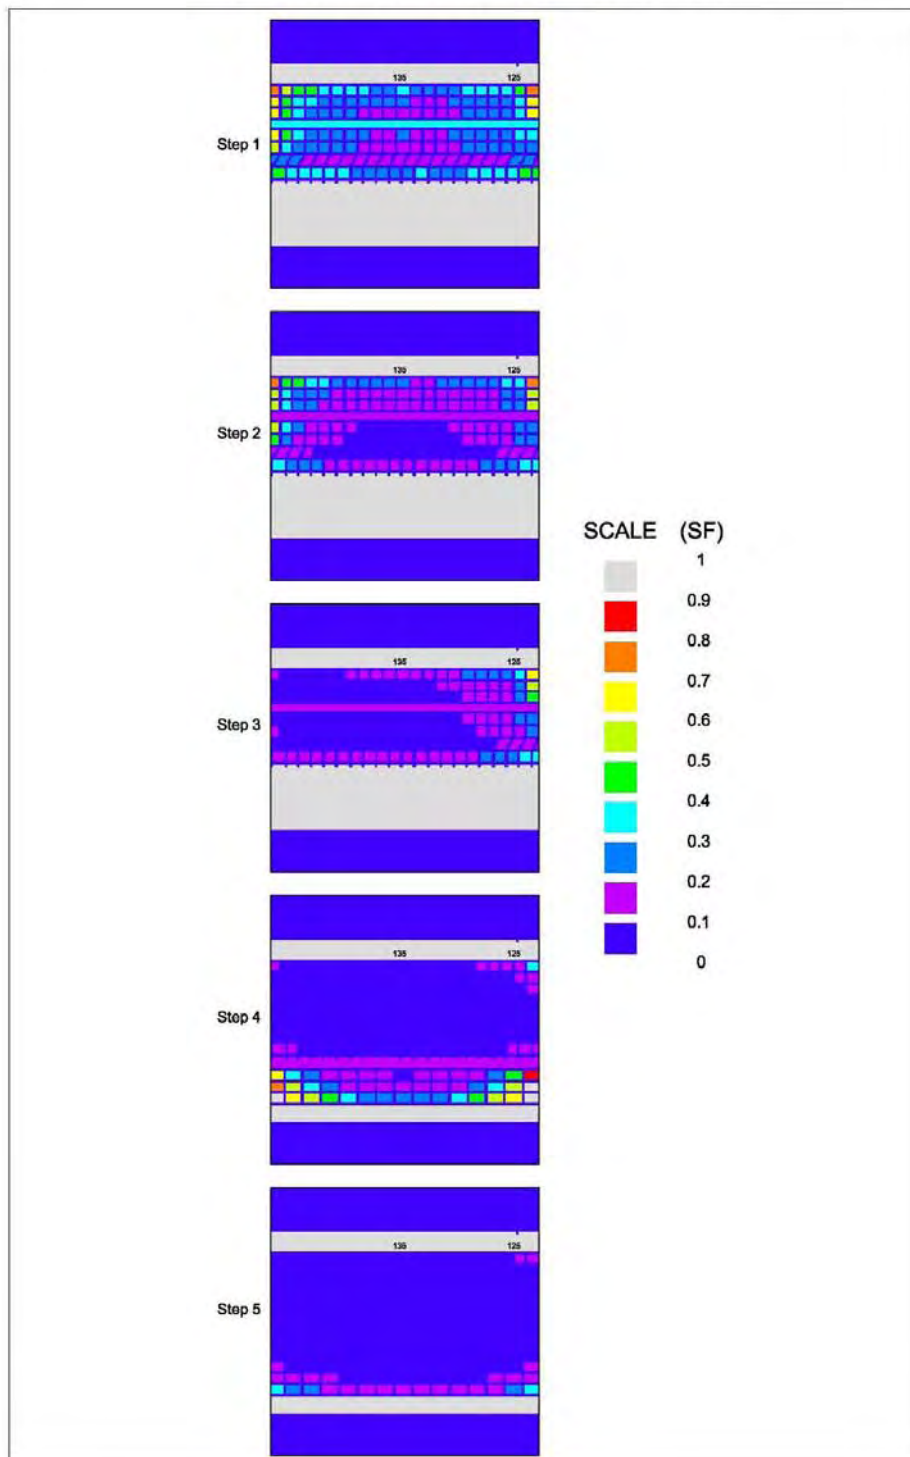
Figure T.9 Five Step Damage Sequence – Pillar Strain SF (LaModel)

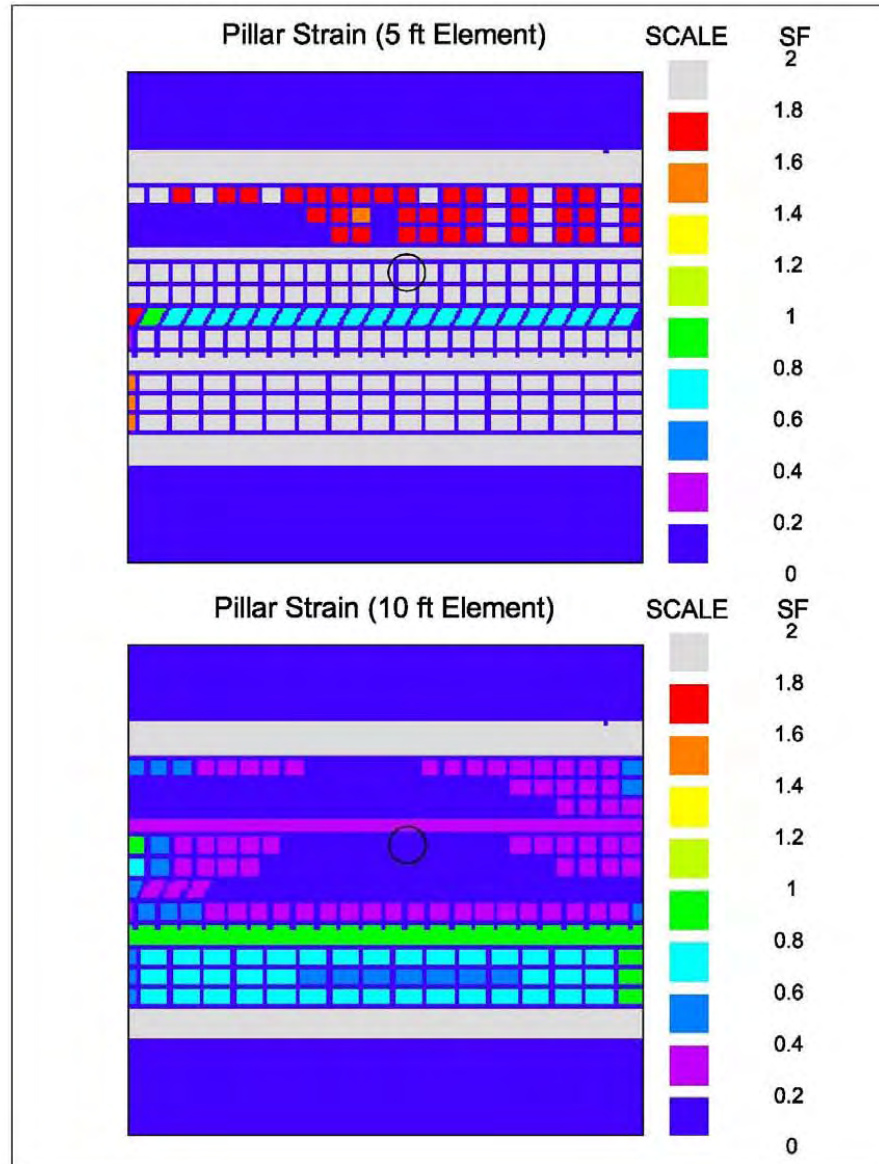
**Figure T.10 Element Size Comparison - Pillar Strain SF
(LaModel)**

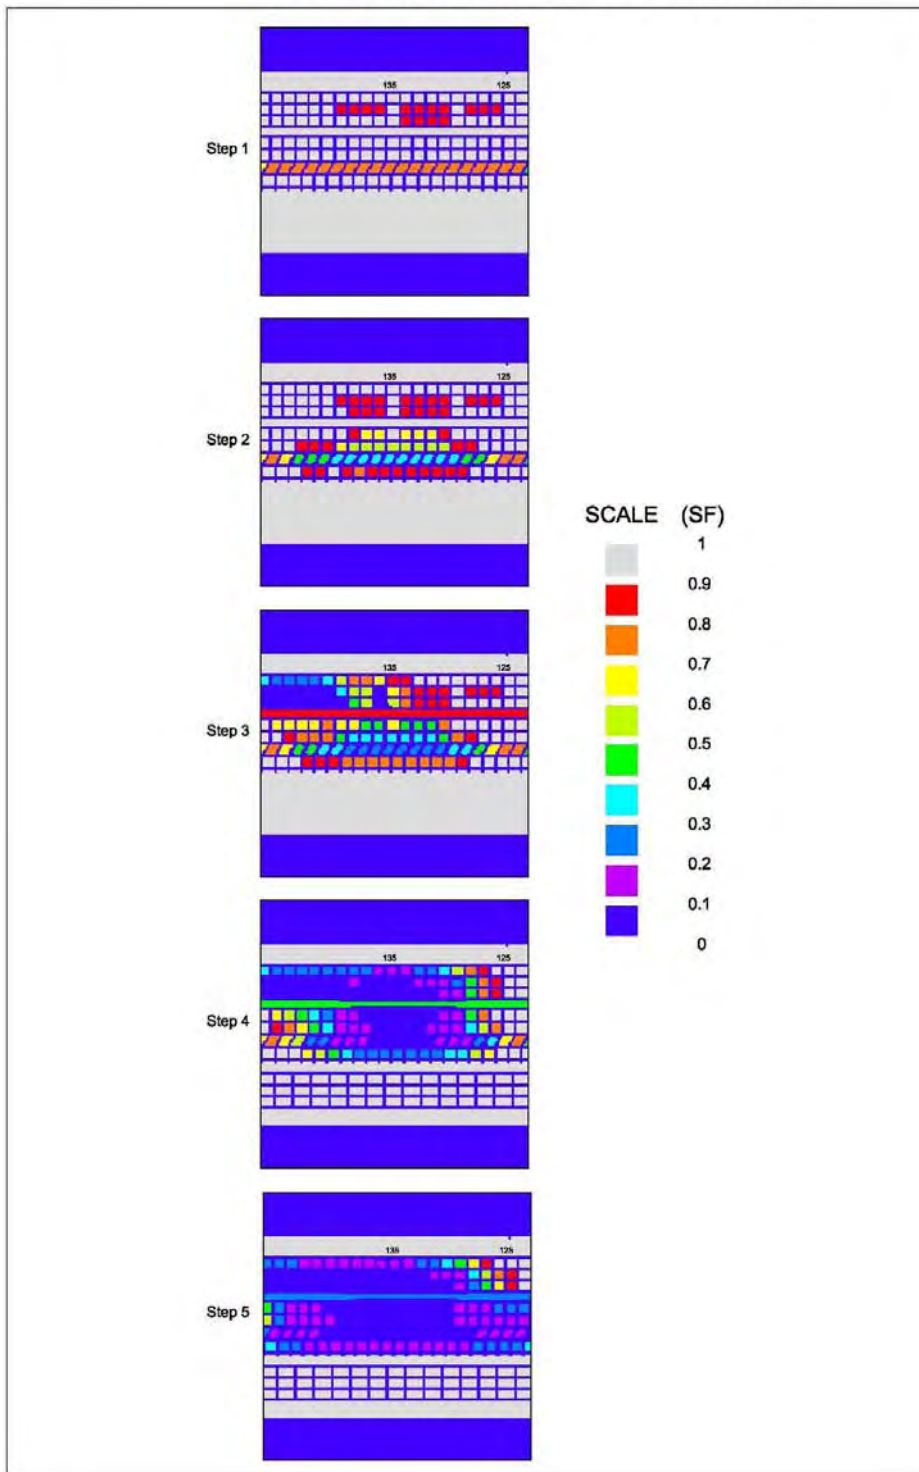
Figure T.11 Five Step Sequence (1250 psi) – Pillar Strain SF (LaModel)

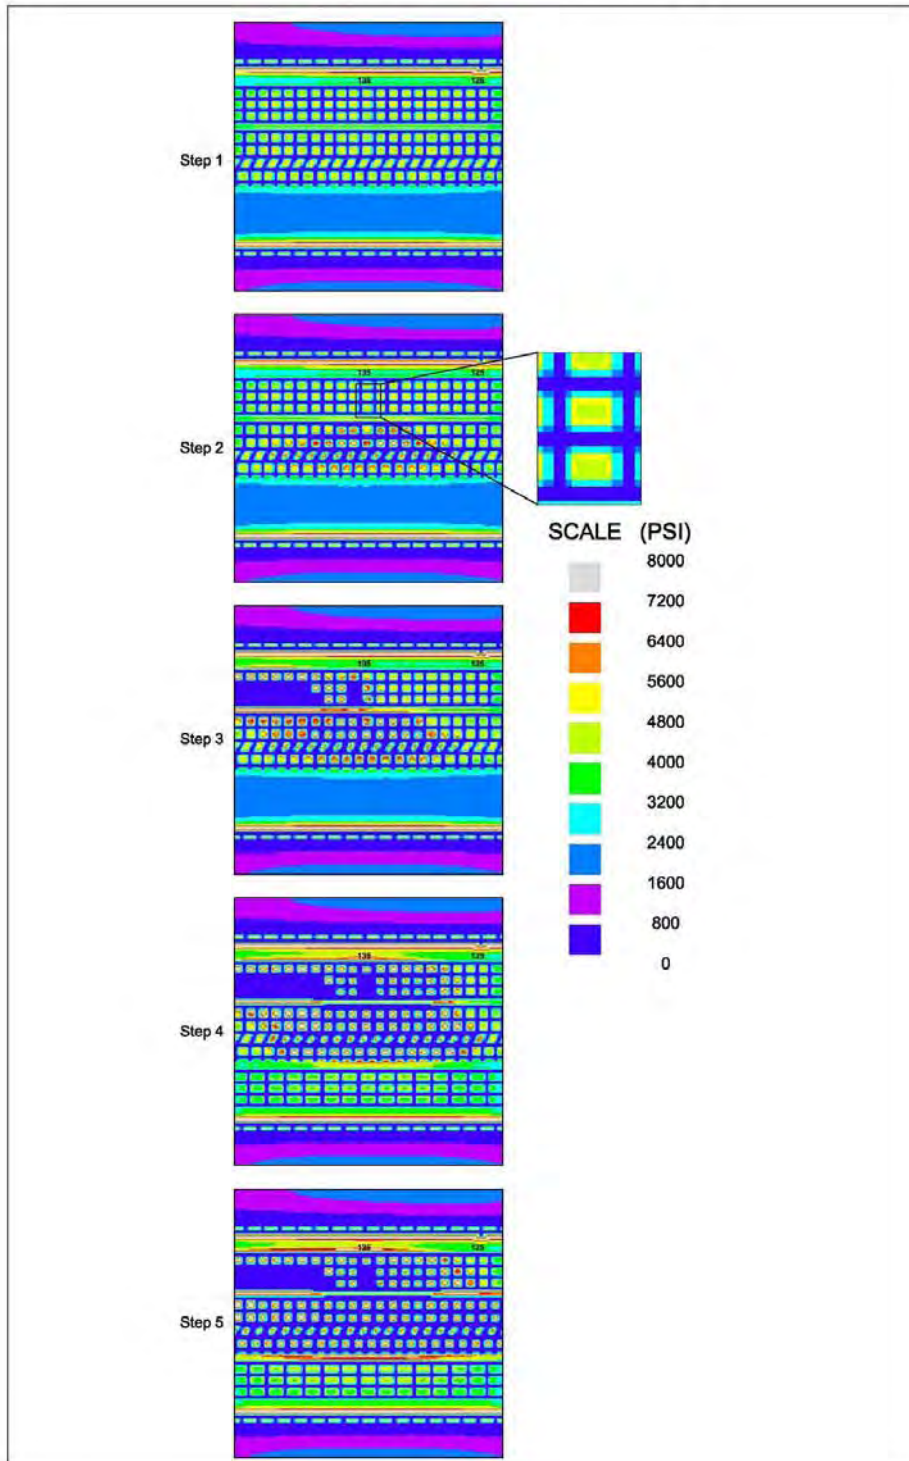
Figure T.12 Five Step Sequence (1250 psi) – Vertical Stress

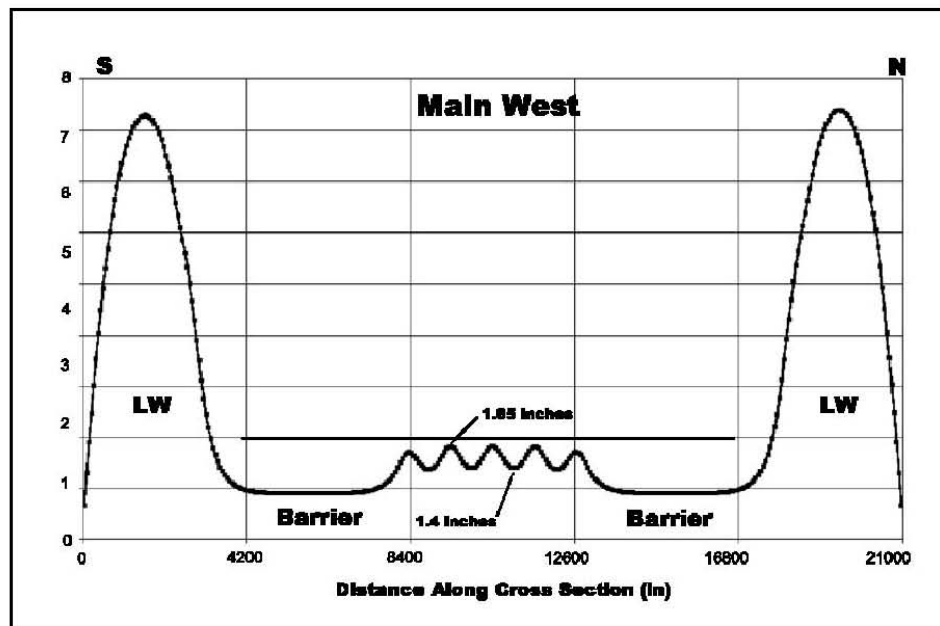
Figure 3.1-1 Convergence Main West (LaM2D)

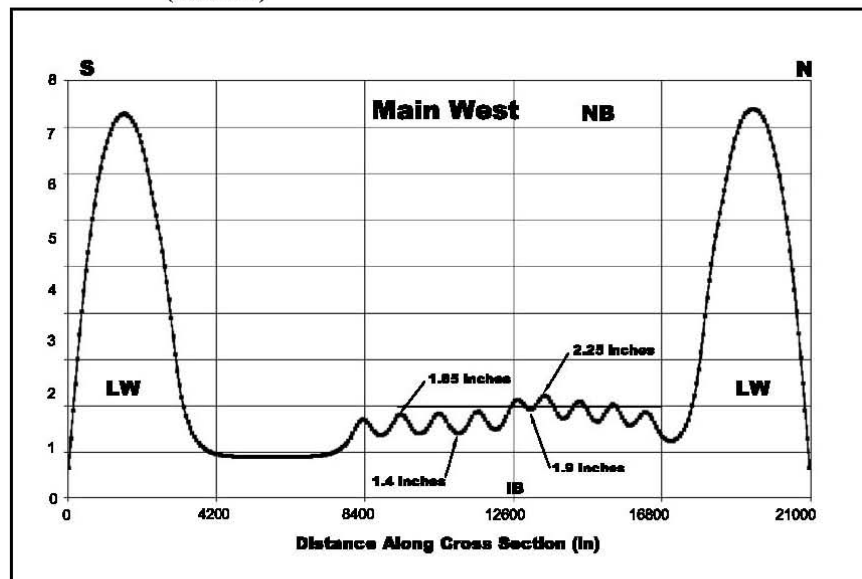
Figure 3.1-2 Convergence Main West and North Barrier (LaM2D)

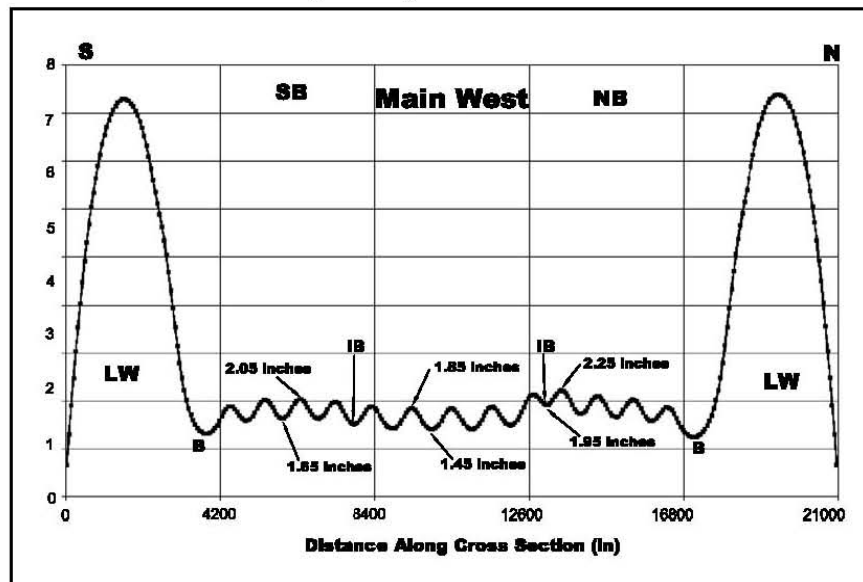
Figure 3.1-3 Convergence Main West, North Barrier and South Barrier (LaM2D)

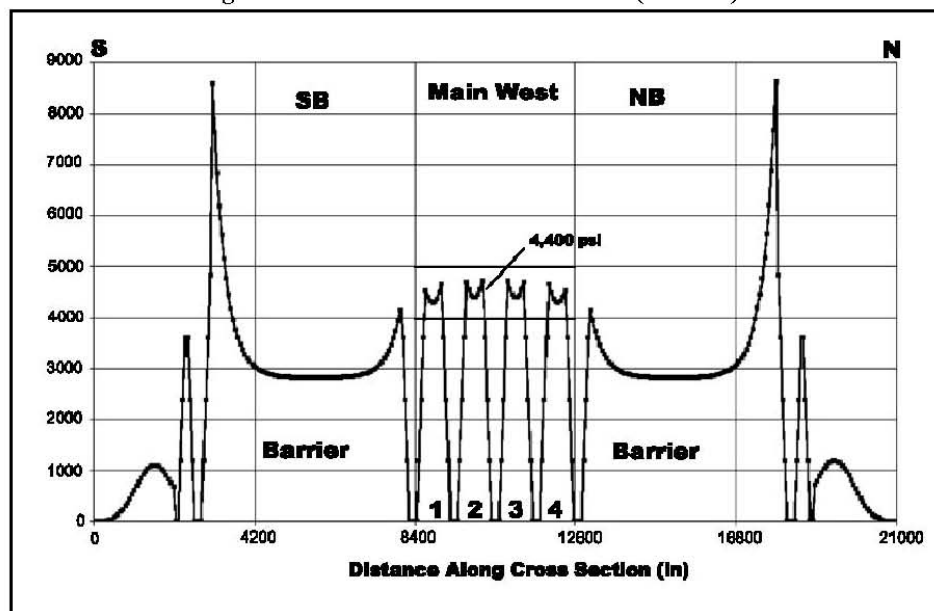
Figure 3.1-4 Vertical Stress Main West (LaM2D)

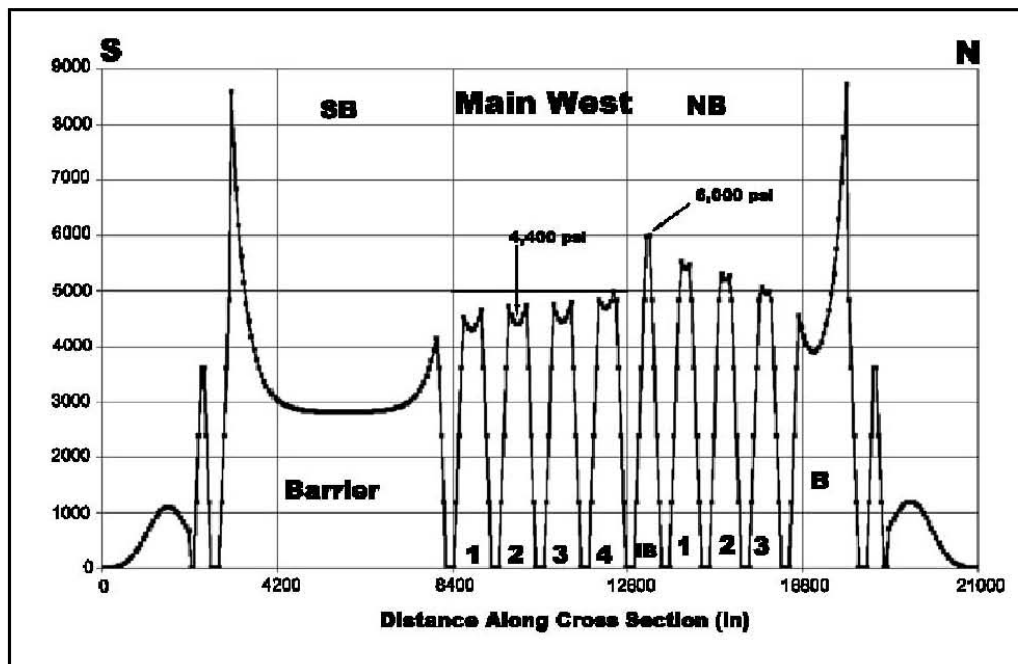
Figure 3.1-5 Vertical Stress Main West and North Barrier (LaM2D)

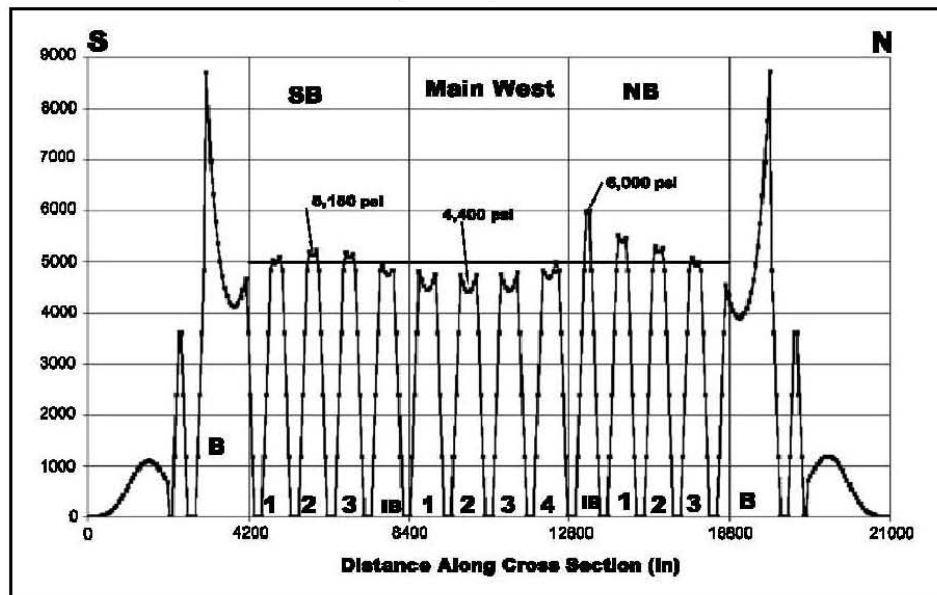
Figure 3.1-6 Vertical Stress Main West, North Barrier and South Barrier (LaM2D)

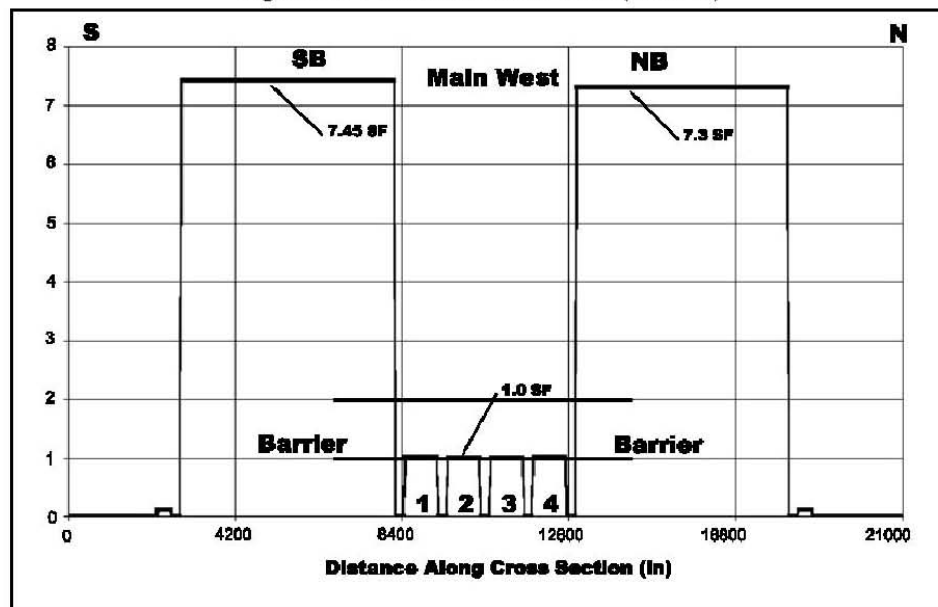
Figure 3.1-7 Strain SF Main West (LaM2D)

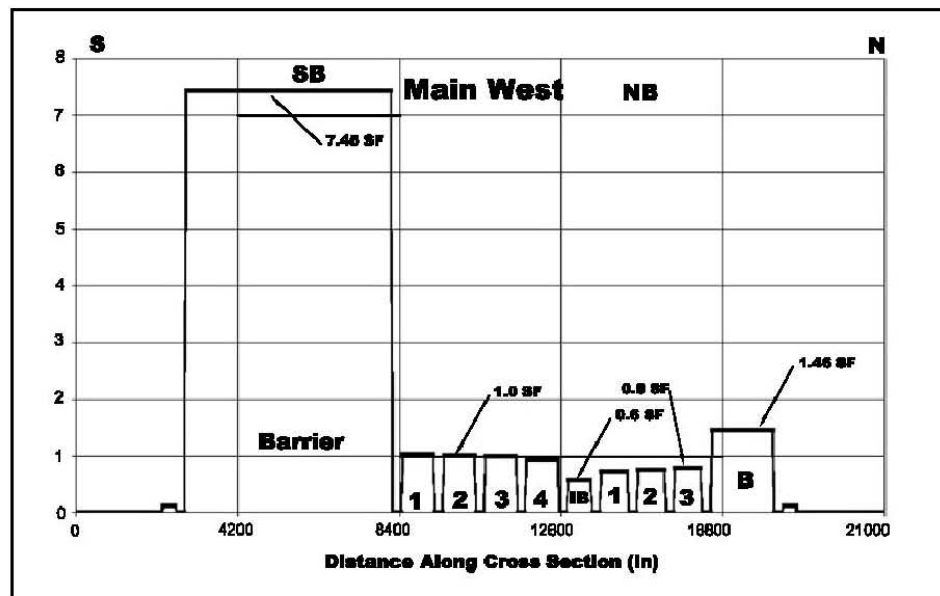
Figure 3.1-8 Strain SF Main West and North Barrier (LaM2D)

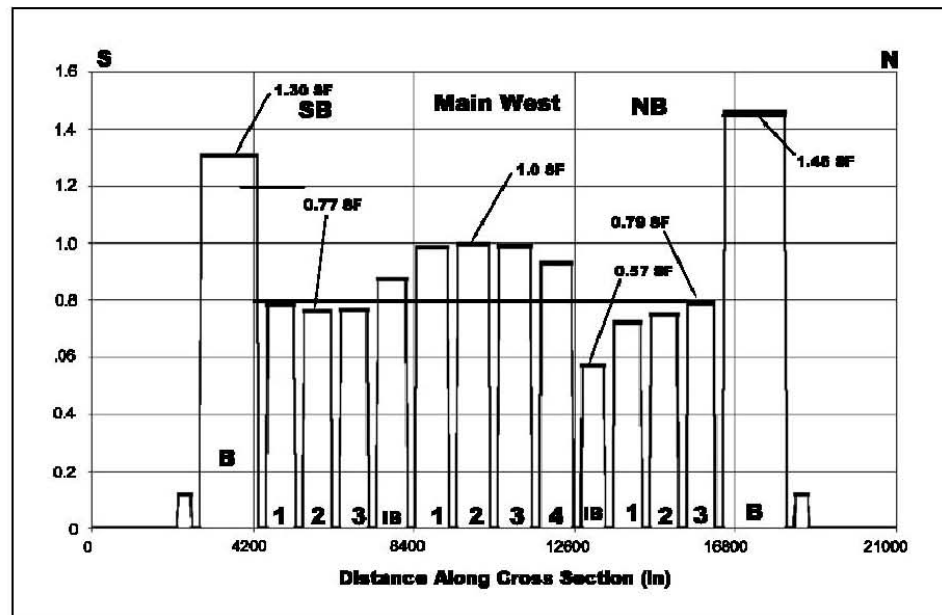
Figure 3.1-9 Strain SF Main West, North Barrier and South Barrier (LaM2D)

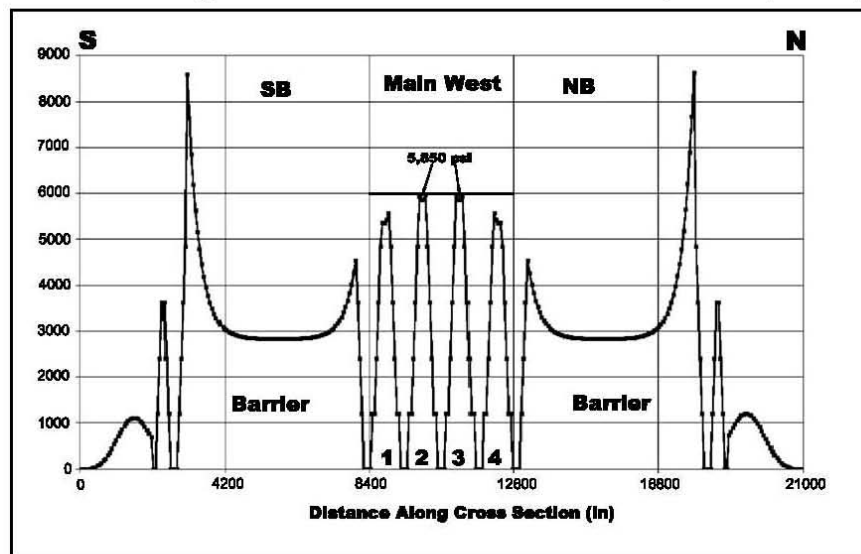
The vertical stress in the Main West with deterioration of the pillars is shown in Figure 3.2-1. Vertical stress in excess of 5,800 psi could create conditions in this area that required the sealing of this area.

Figure 3.2-1 Vertical Stress Main West - Sequence 2 (LaM2D)

The damage sequence portrayed in Figures 3.2-1 through 3.2-7 is not intended to project a chronological timeline of events. The base case sequence did not indicate high vertical stress at an indicator level. A vertical stress field increase is expected during all forms of retreat mining and this vertical stress increase is a basic fact. Successful retreat mining occurs when the increased vertical stresses are designed to be maintained on the pillars immediately adjacent to the forming gob area.

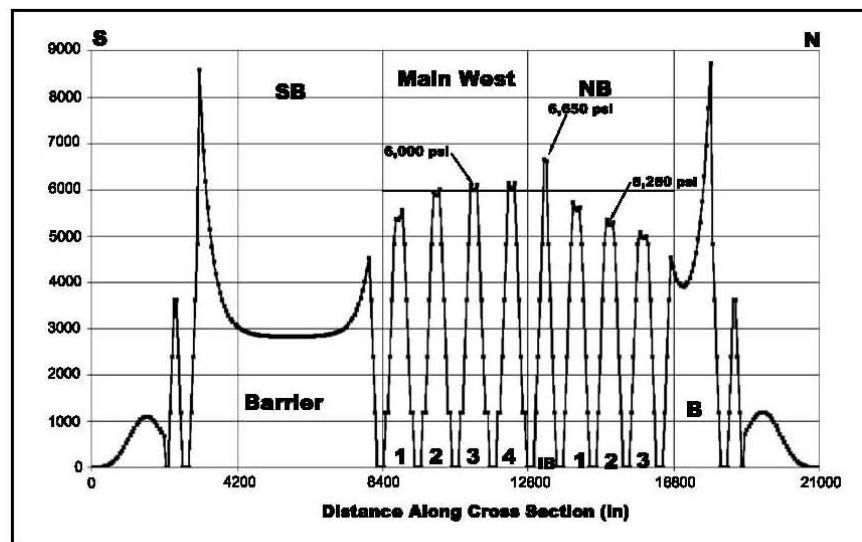
Figure 3.2-2 Vertical Stress Main West and North Barrier - Sequence 3 (LaM2D)

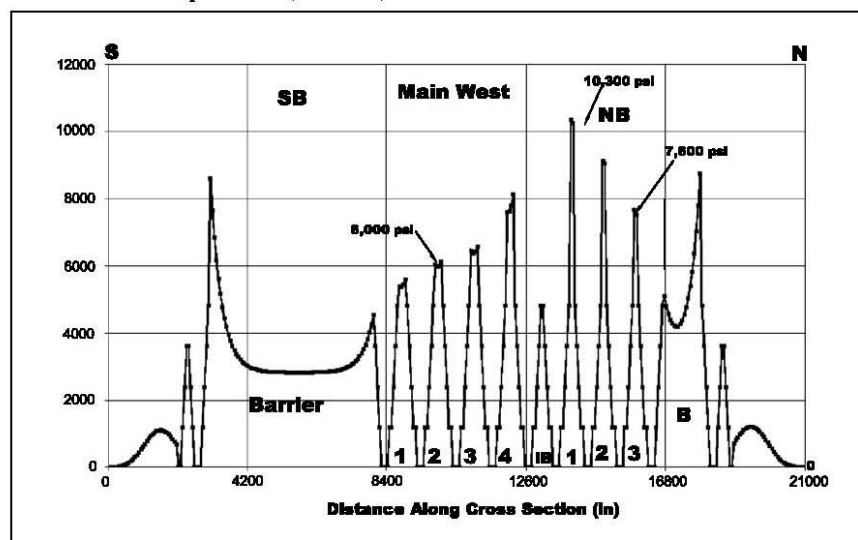
Figure 3.2-3 Vertical Stress Main West and North Barrier - Sequence 4 (LaM2D)

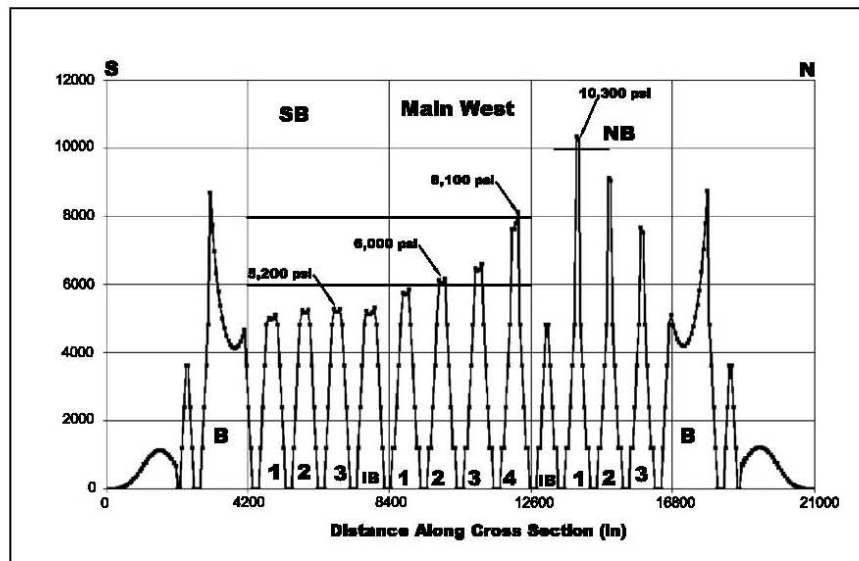
Figure 3.2-4 Vertical Stress Main West, North Barrier and South Barrier - Sequence 5 (LaM2D)

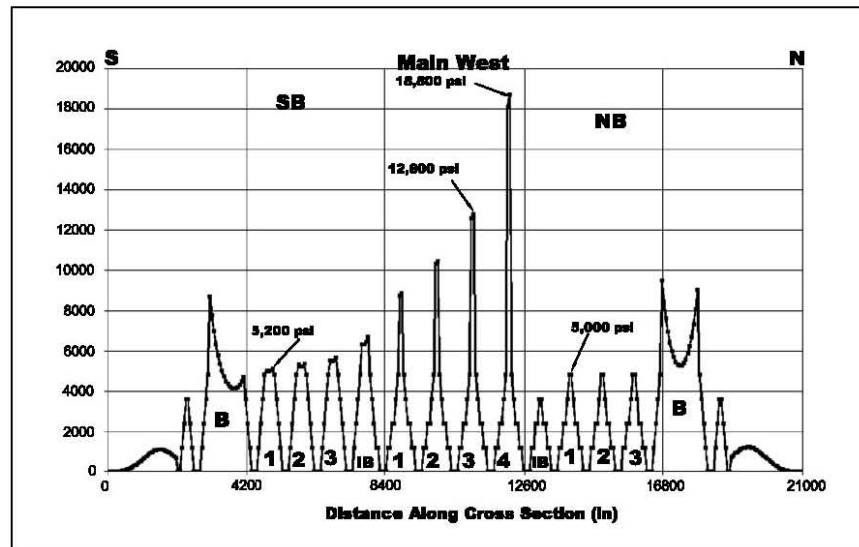
Figure 3.2-5 Vertical Stress Main West, North Barrier and South Barrier - Sequence 6 (March Bounce) (LaM2D)

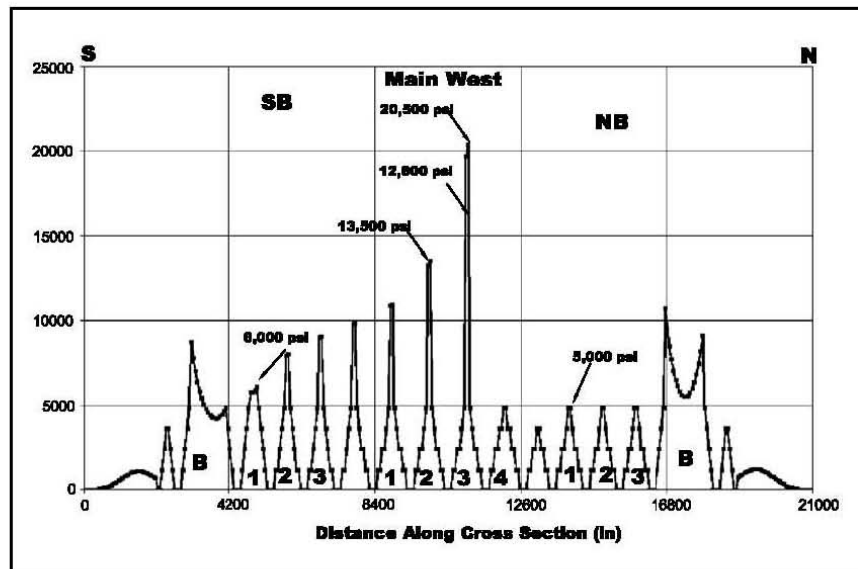
Figure 3.2-6 Vertical Stress Main West, North Barrier and South Barrier - Sequence 6a (LaM2D)

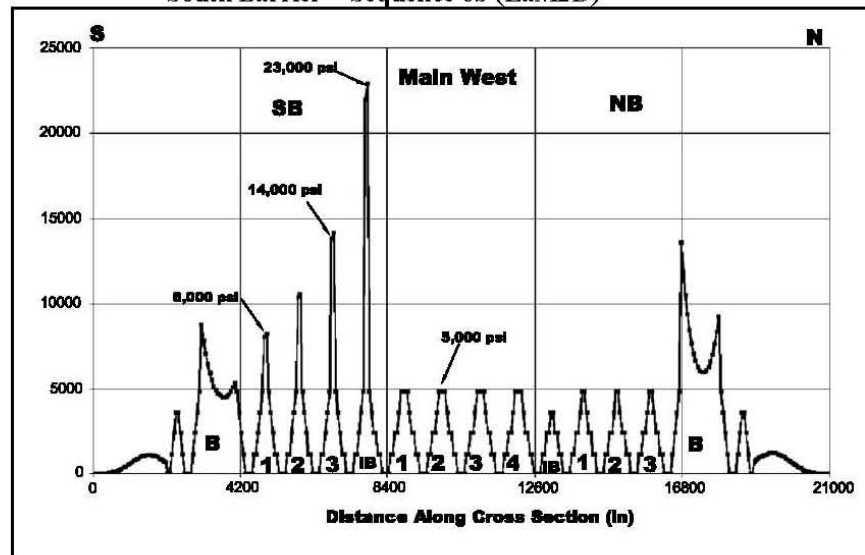
Figure 3.2-7 Vertical Stress Main West, North Barrier and South Barrier - Sequence 6b (LaM2D)

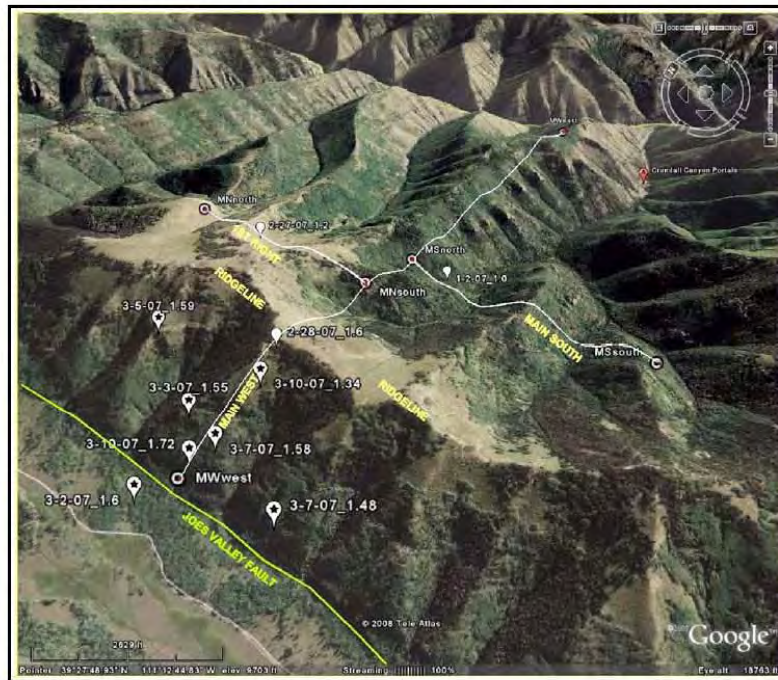
Figure 3.3-1 Seismic Events January 2007 through March 10, 2007

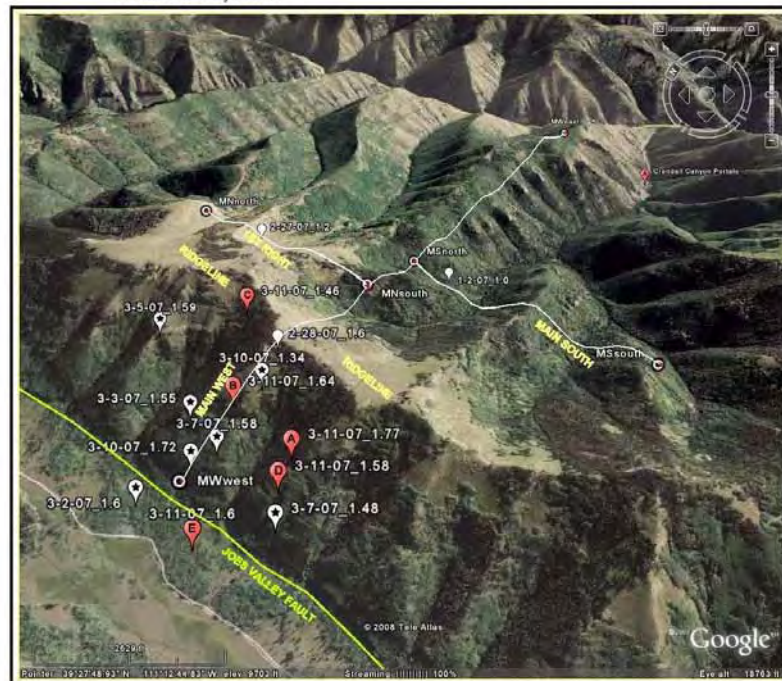
Figure 3.3-2 Seismic Events January 2007 through March 11, 2007

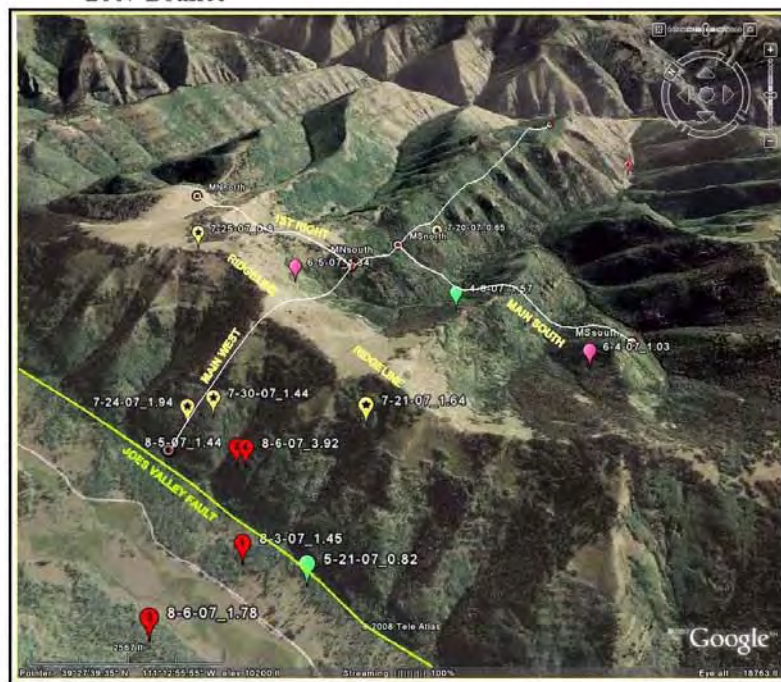
Figure 3.3-3 Seismic Events March 12, 2007 through August 6, 2007 Bounce

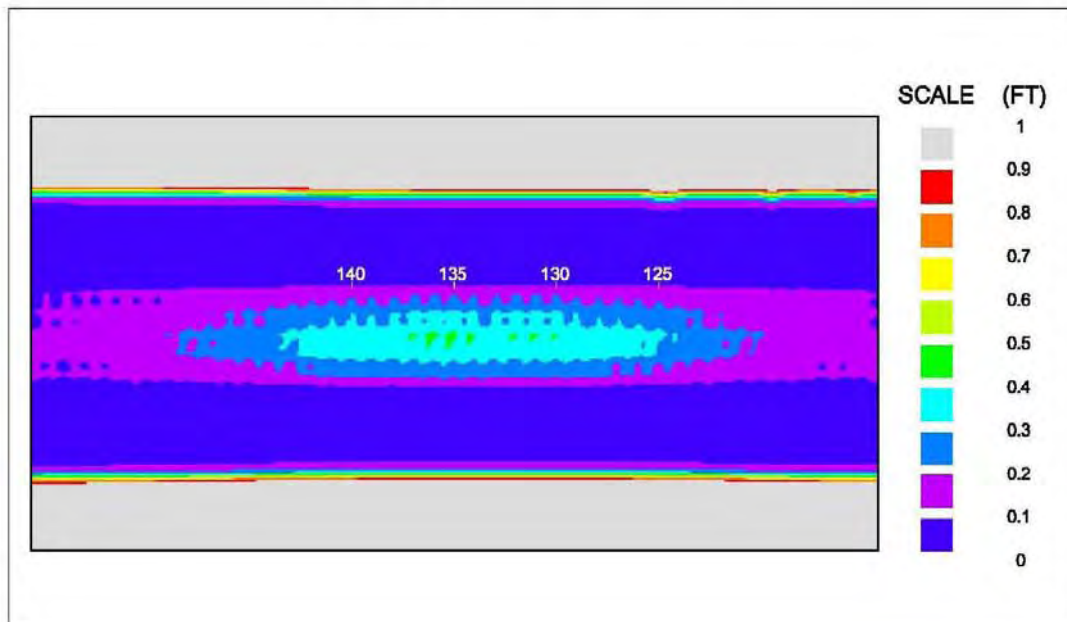
Figure 3.4-1 Base Case Seam Convergence Main West (LaModel)

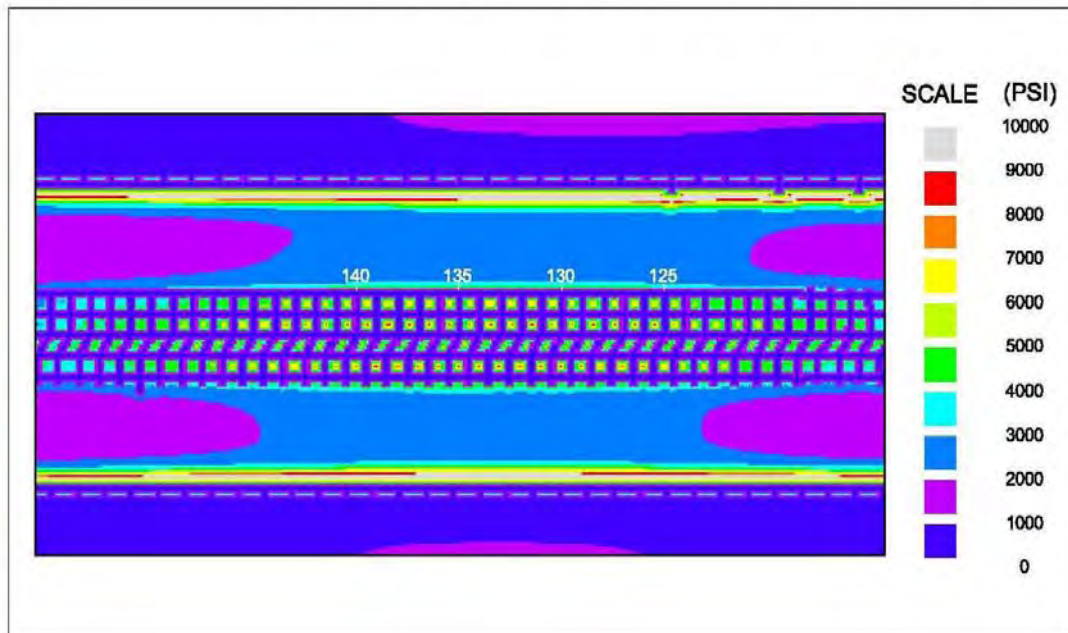
Figure 3.4-2 Base Case Vertical Stress Main West (LaModel)

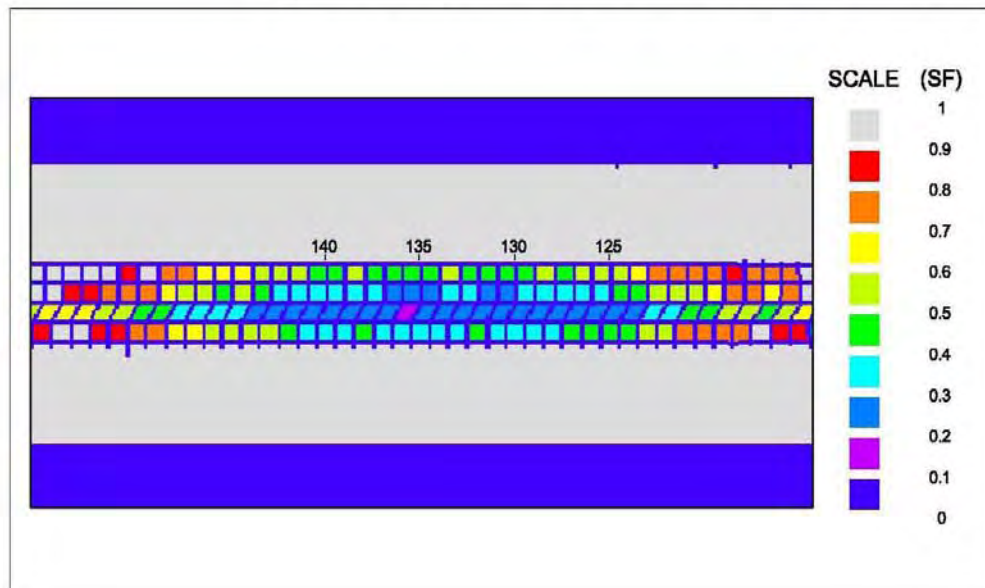
Figure 3.4-3 Base Case Pillar Strain SF Main West (LaModel)

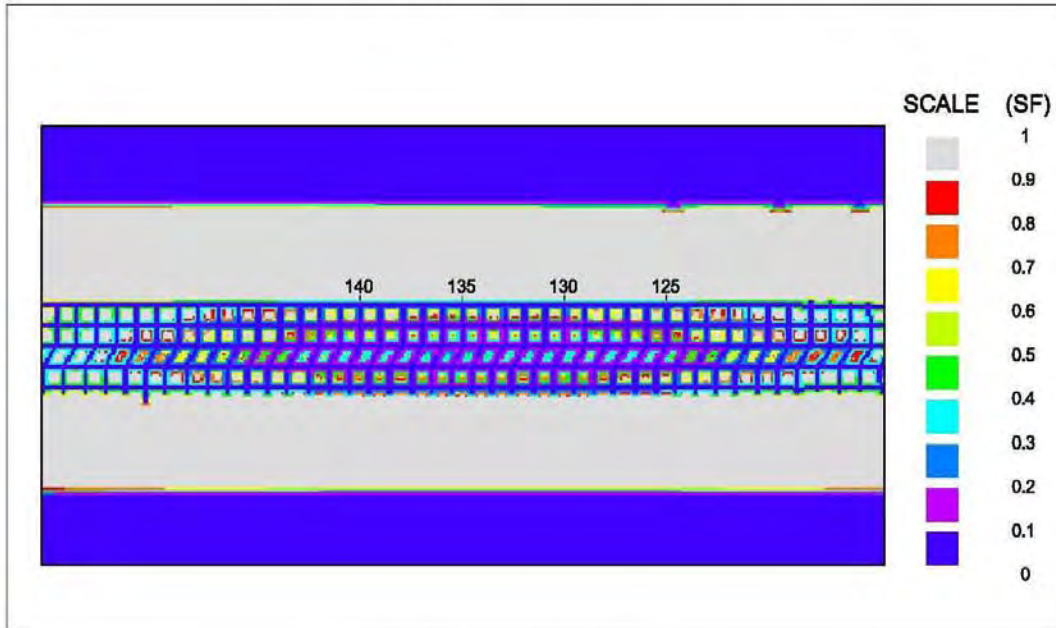
Figure 3.4-4 Base Case Element Strain SF Main West (LaModel)
