Memorandum from the Chairman to the Members of the Committee on Education and Labor

Regarding the August 2007 Disaster at the
Crandall Canyon Mine

May 8, 2008
Congressman George Miller, Chairman

3717-CRANDALL CANYON MINE
ROOF CONTROL PLAN REVIEW
US HOUSE COMMITTEE ON EDUCATION AND LABOR

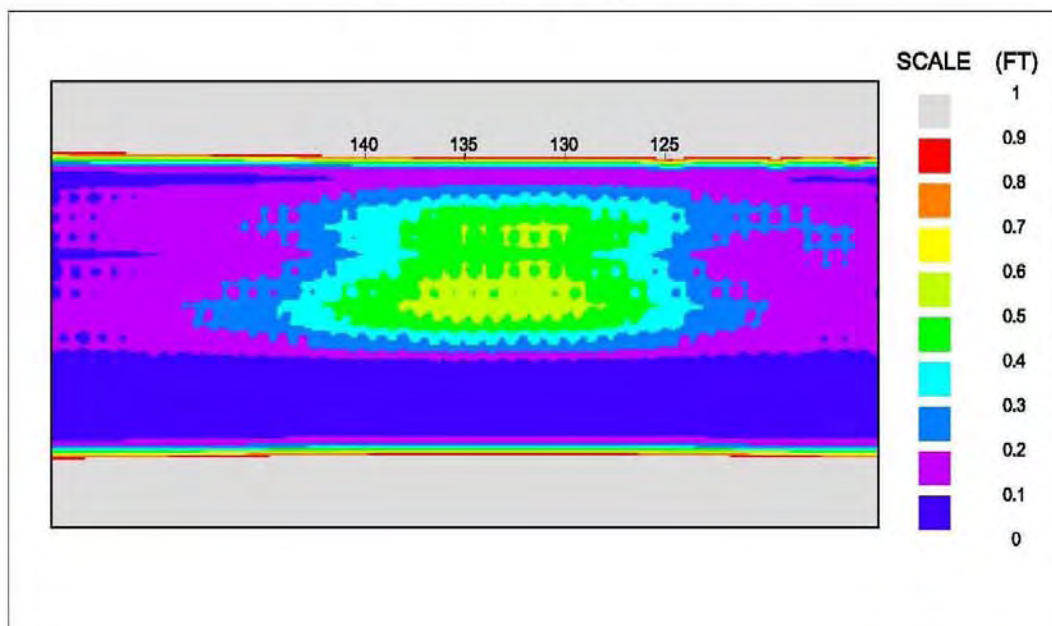
Figure 3.5-1 Base Case Seam Convergence – Main West and North Barrier (LaModel)

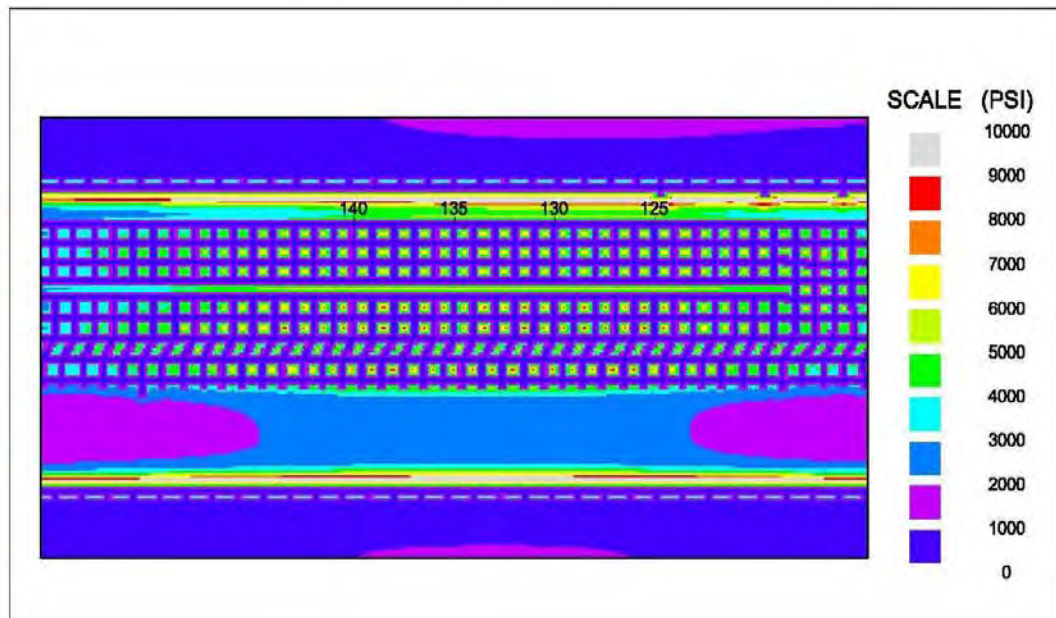
Figure 3.5-2 Base Case Vertical Stress – Main West and North Barrier (LaModel)

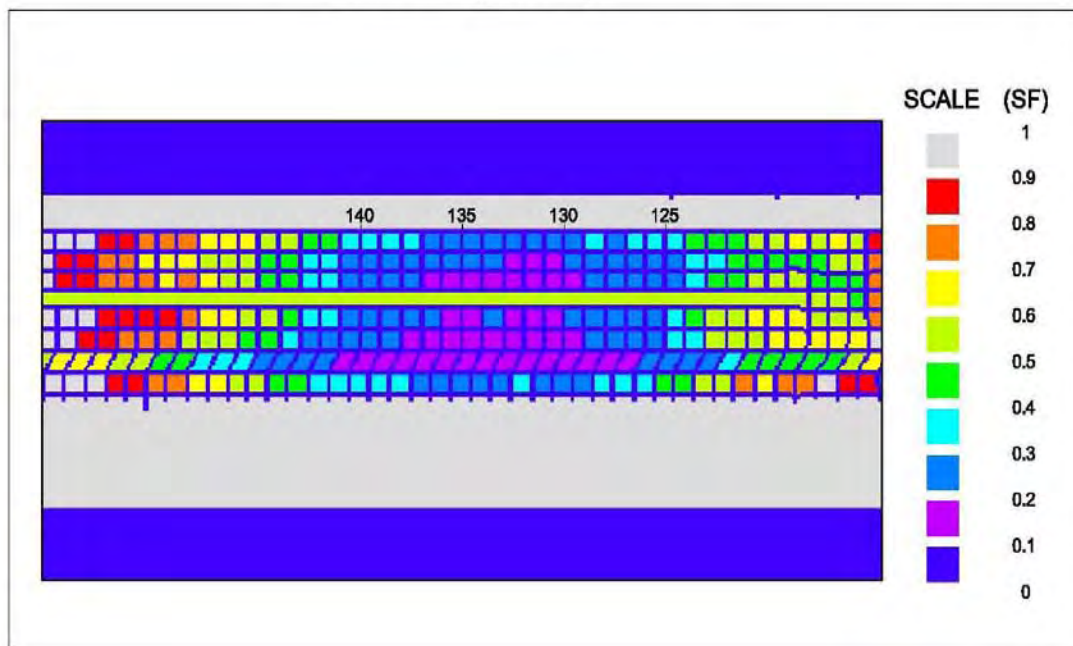
Figure 3.5-3 Base Case Pillar Strain SF – Main West and North Barrier (LaModel)

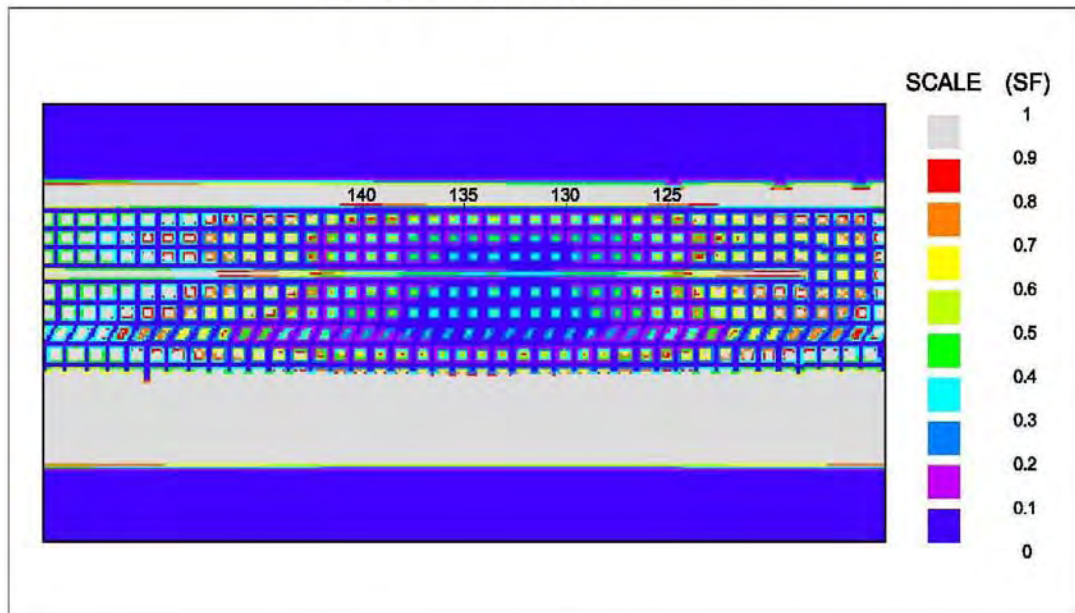
Figure 3.5-4 Base Case Element Strain SF – Main West and North Barrier (LaModel)

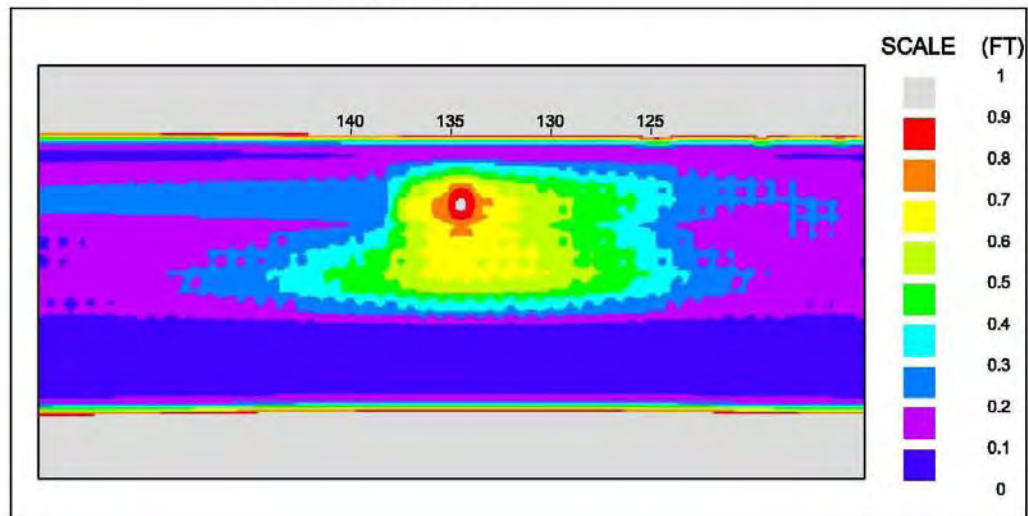
Figure 3.6-1 Base Case Seam Convergence – North Barrier Retreat (LaModel)

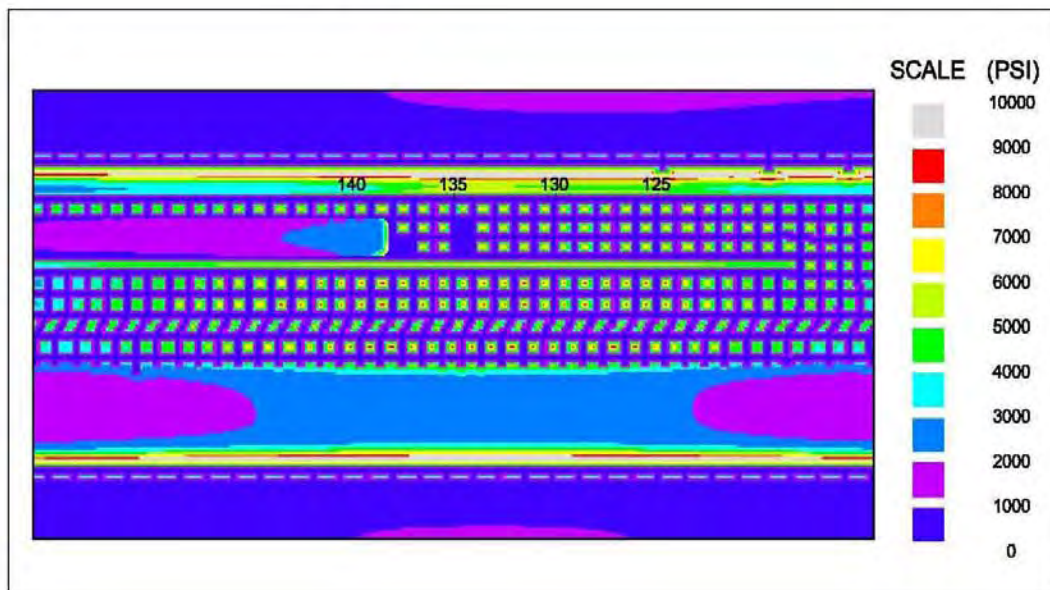
Figure 3.6-2 Base Case Vertical Stress – North Barrier Retreat (LaModel)

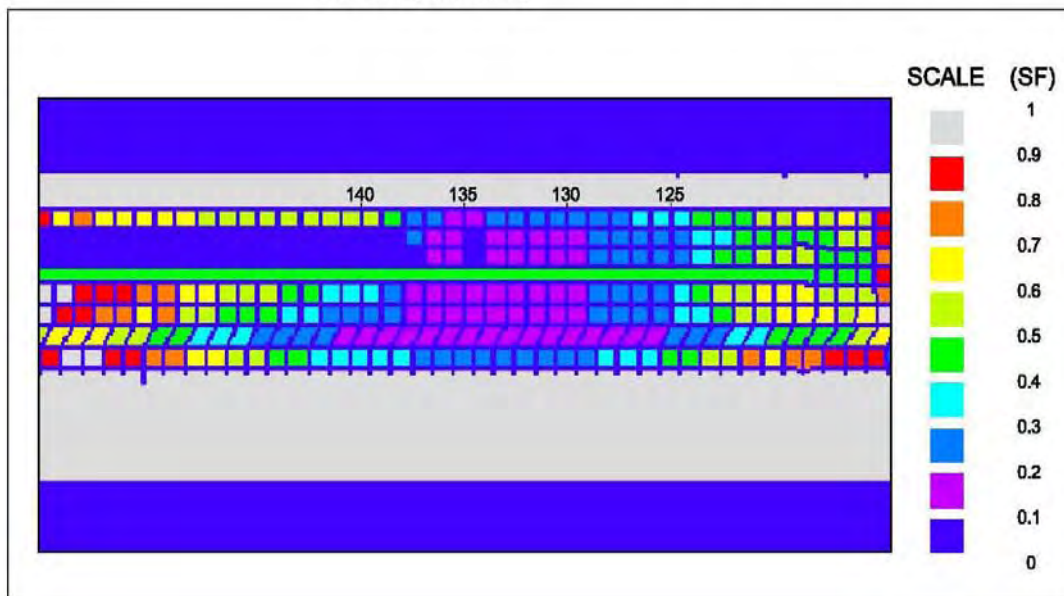
Figure 3.6-3 Base Case Pillar Strain SF – North Barrier Retreat (LaModel)

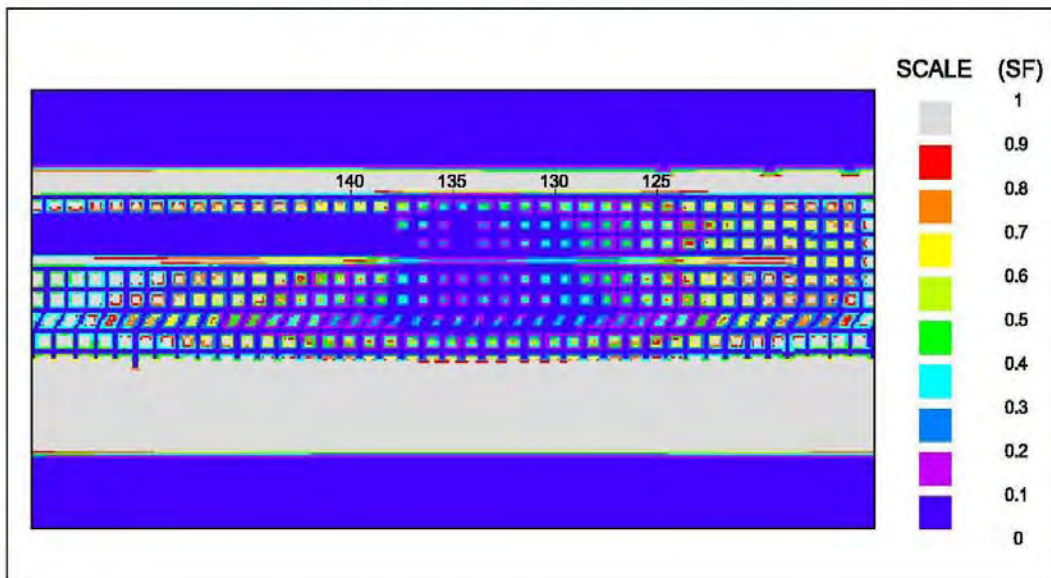
Figure 3.6-4 Base Case Element Strain SF – North Barrier Retreat (LaModel)

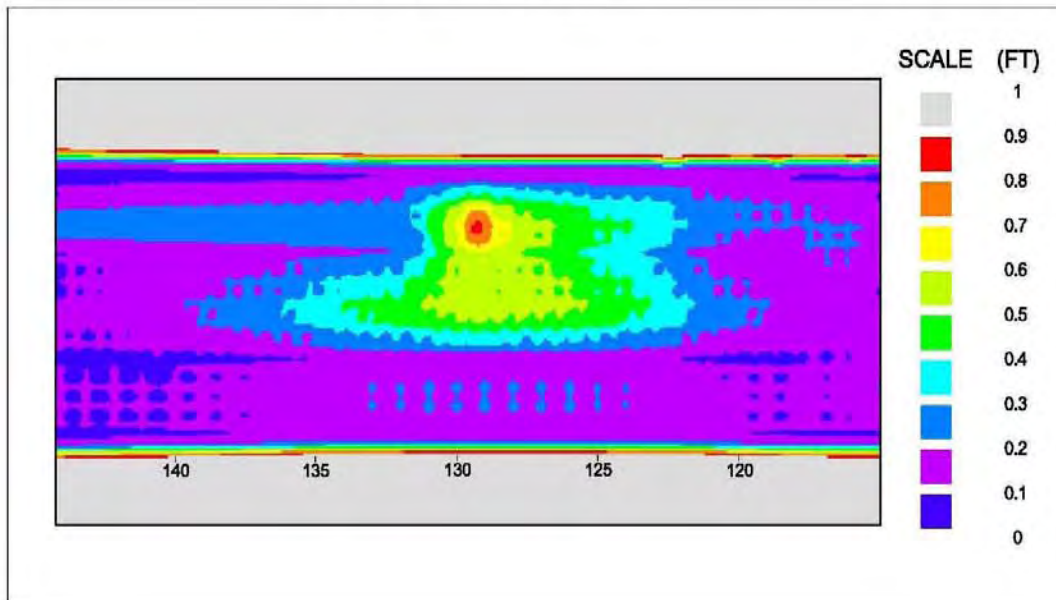
Figure 3.7-1 Base Case Seam Convergence – South Barrier Development (LaModel)

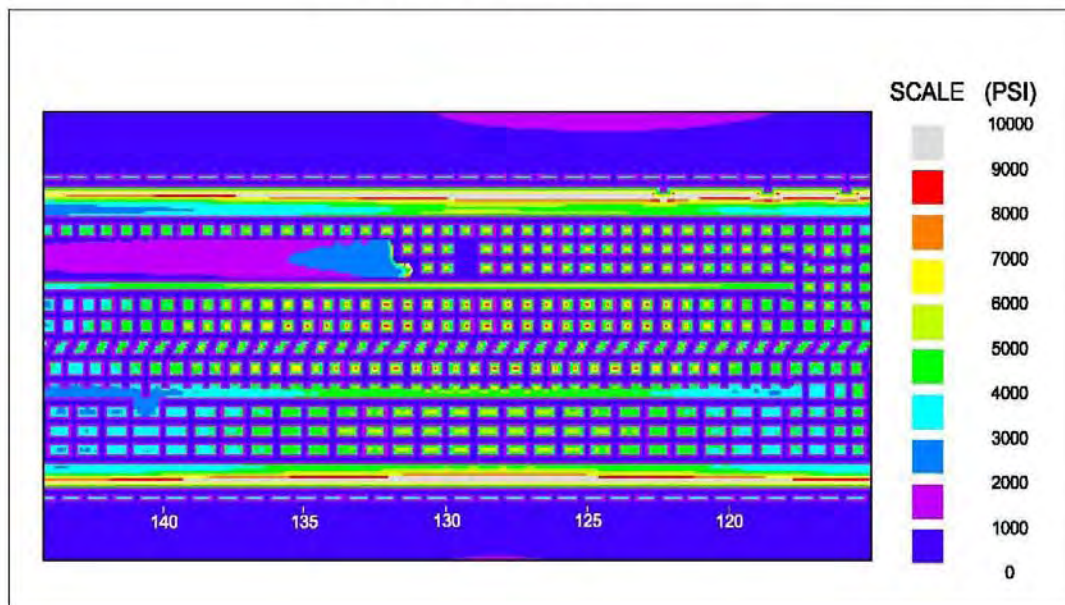
Figure 3.7-2 Base Case Vertical Stress – South Barrier Development (LaModel)

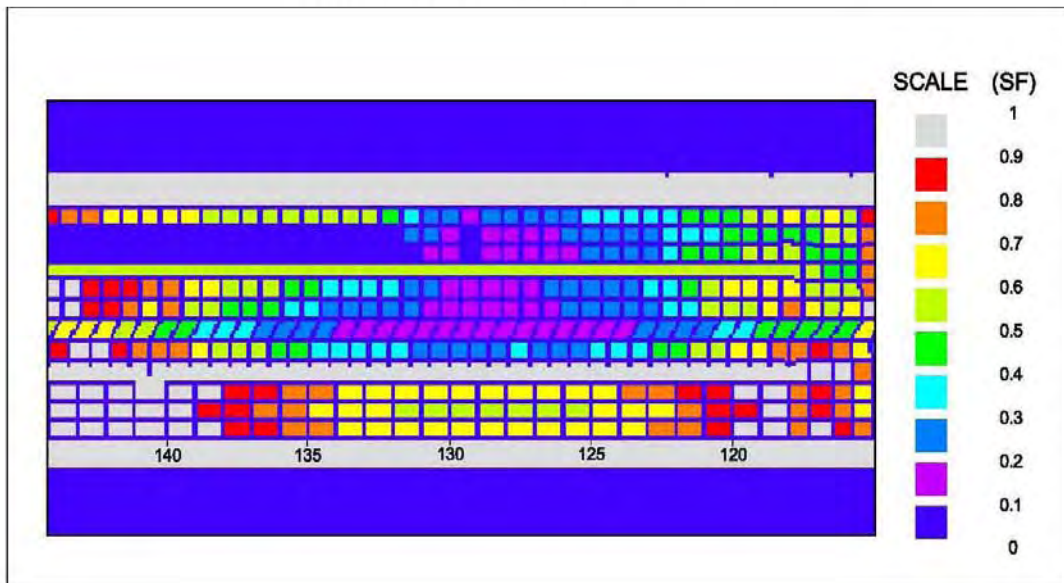
Figure 3.7-3 Base Case Pillar Strain SF – South Barrier Development (LaModel)

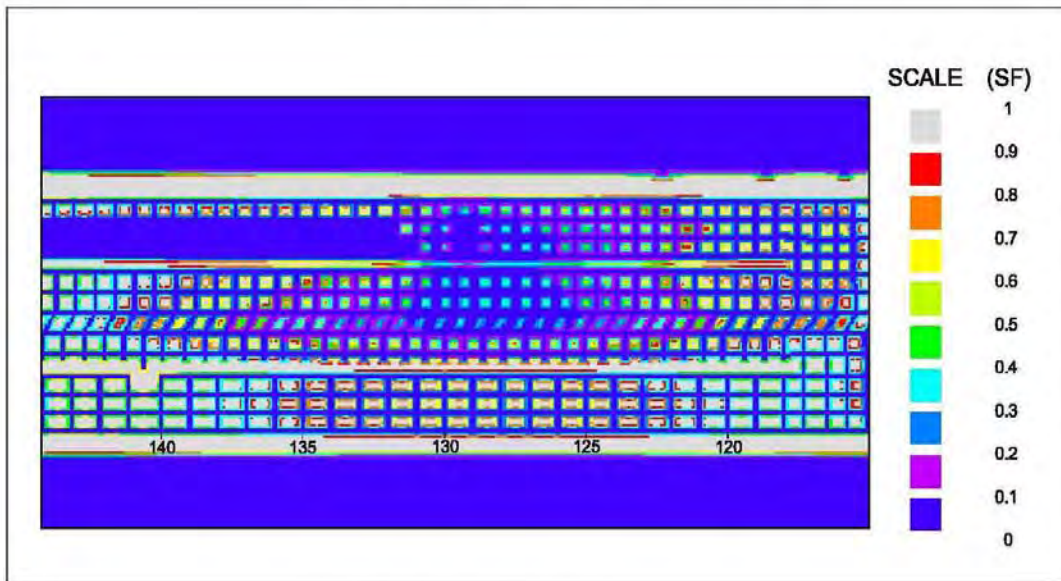
Figure 3.7-4 Base Case Element Strain SF – South Barrier Development (LaModel)

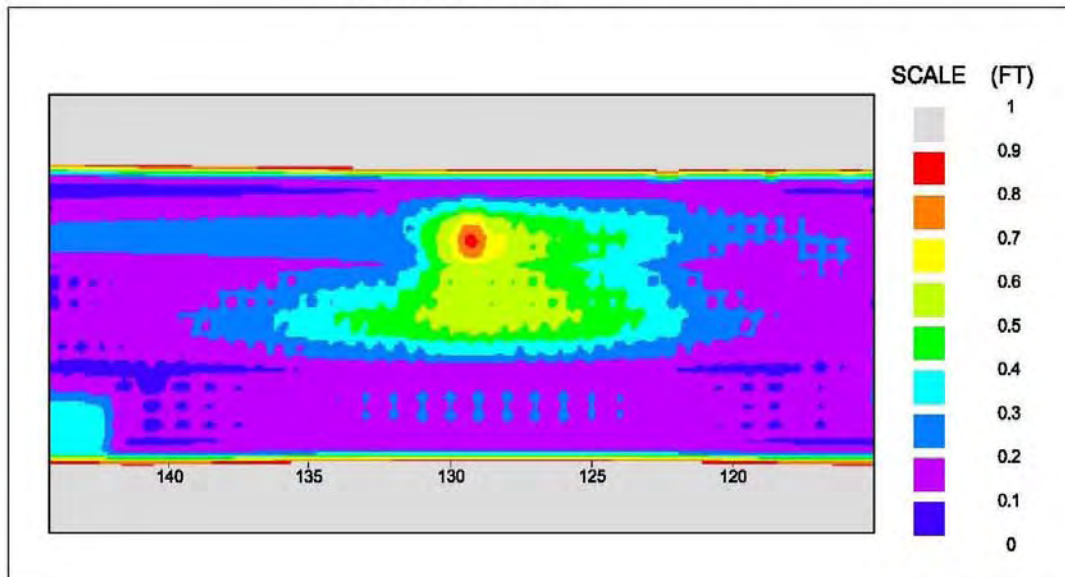
Figure 3.8-1 Base Case Seam Convergence - South Barrier Retreat (LaModel)

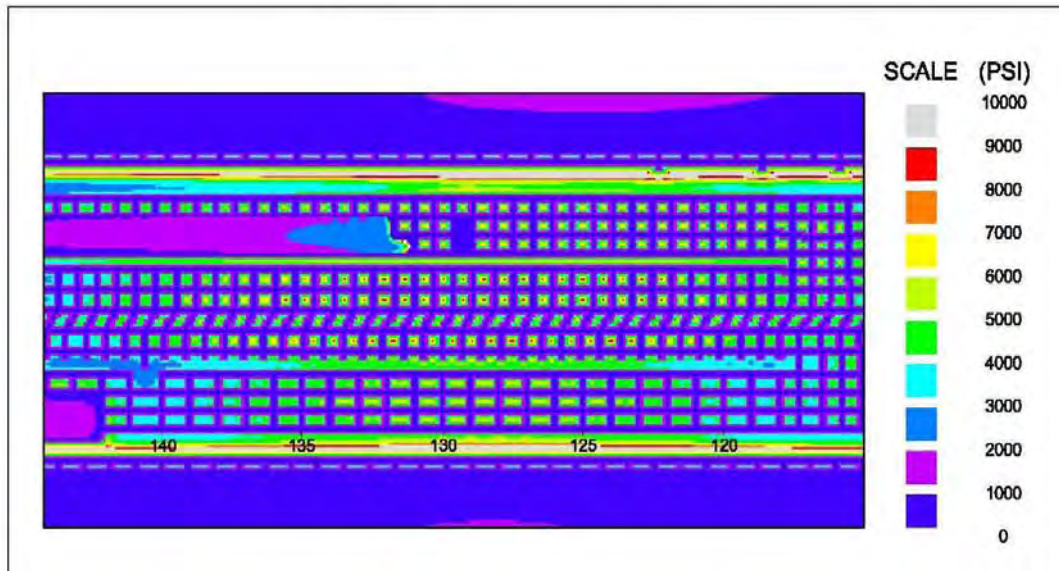
Figure 3.8-2 Base Case Vertical Stress - South Barrier Retreat (LaModel)

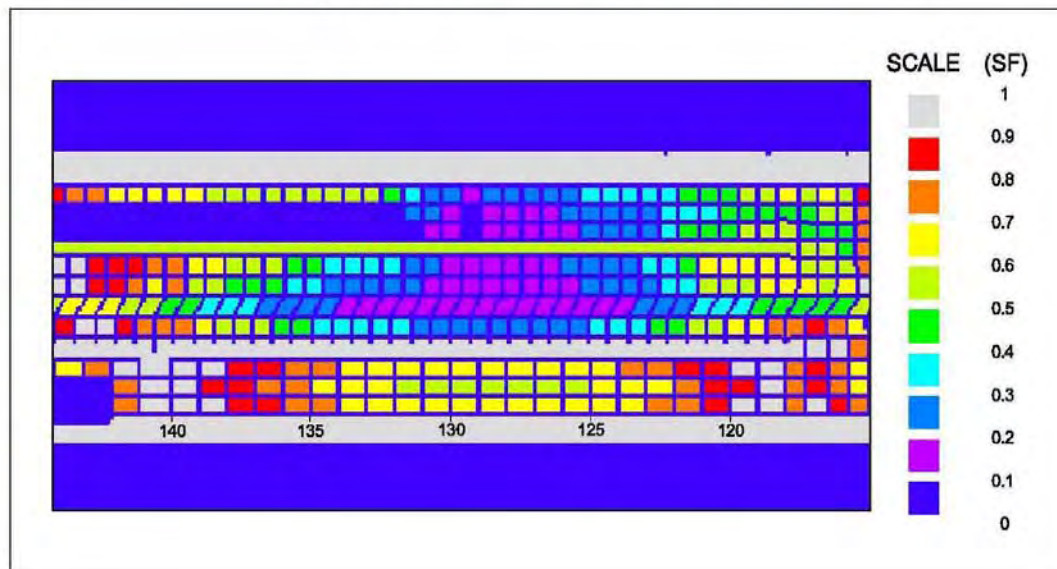
Figure 3.8-3 Base Case Pillar Strain SF - South Barrier Retreat (LaModel)

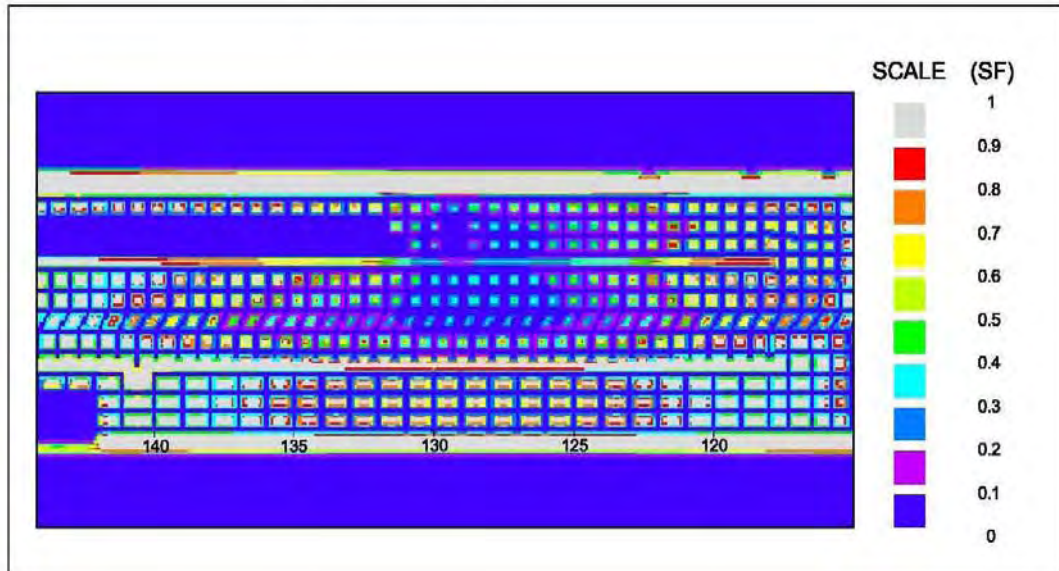
Figure 3.8-4 Base Case Element Strain SF - South Barrier Retreat (LaModel)

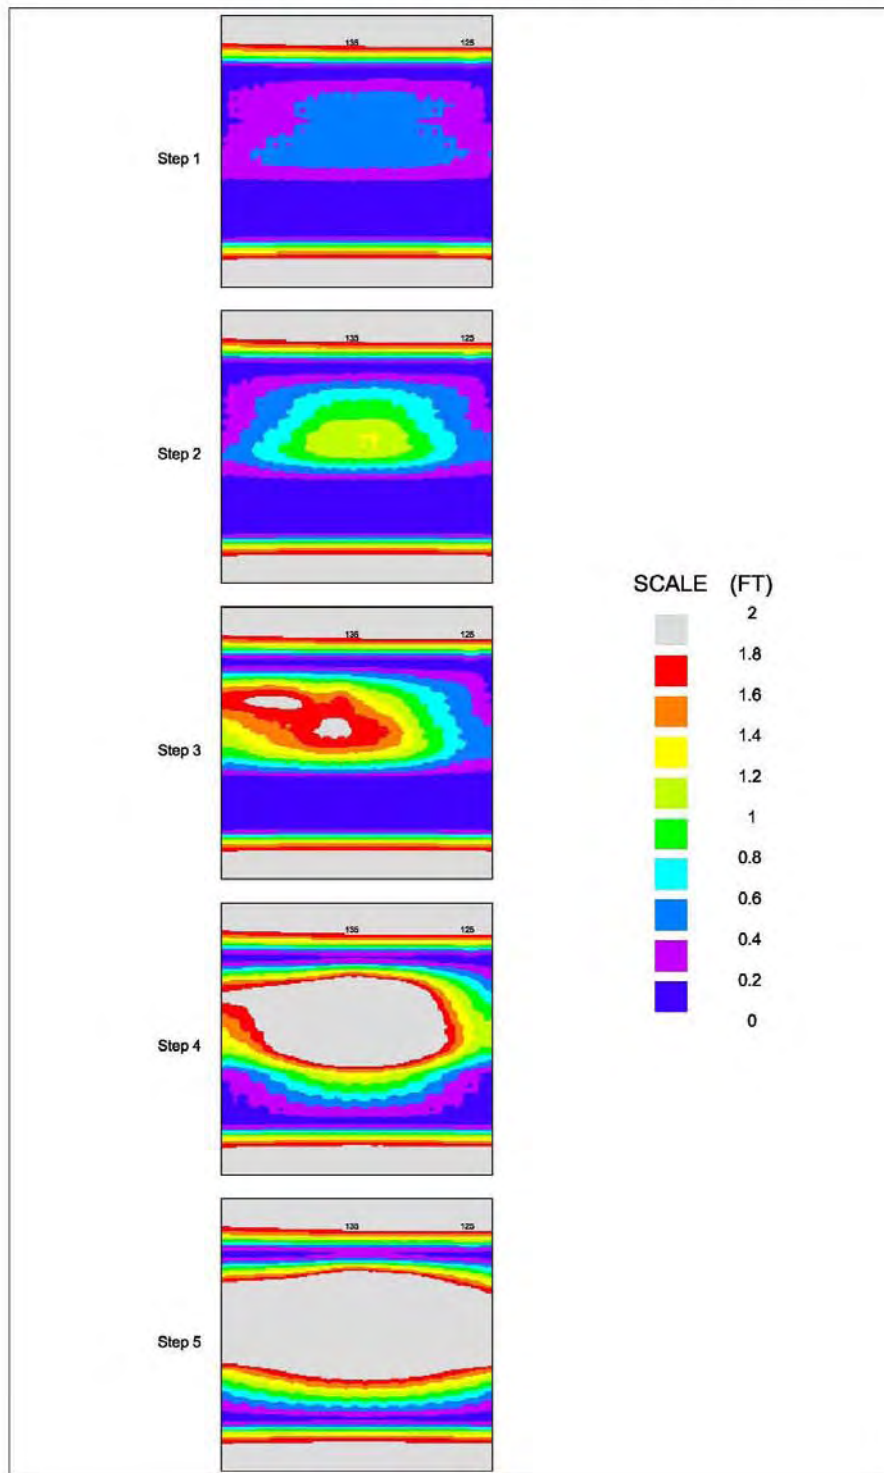
Figure 3.9-1 Five Step Damage Sequence - Seam Convergence (LaModel)

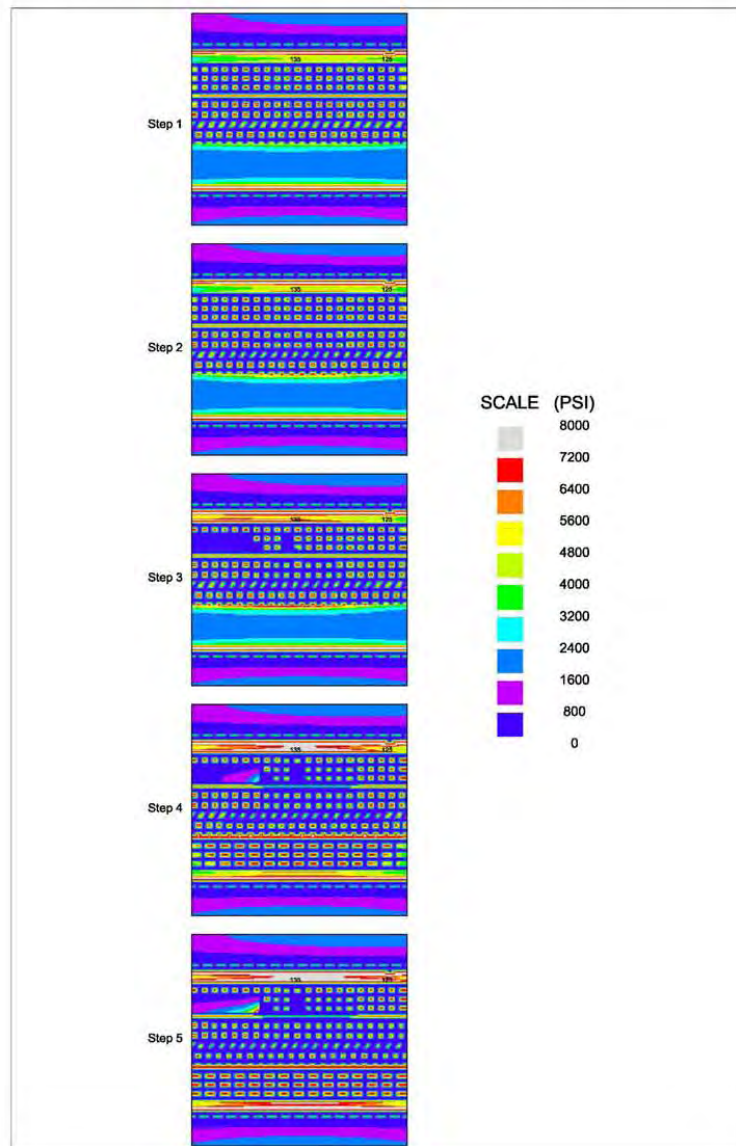
Figure 3.9-2 Five Step Damage Sequence – Vertical Stress (LaModel)

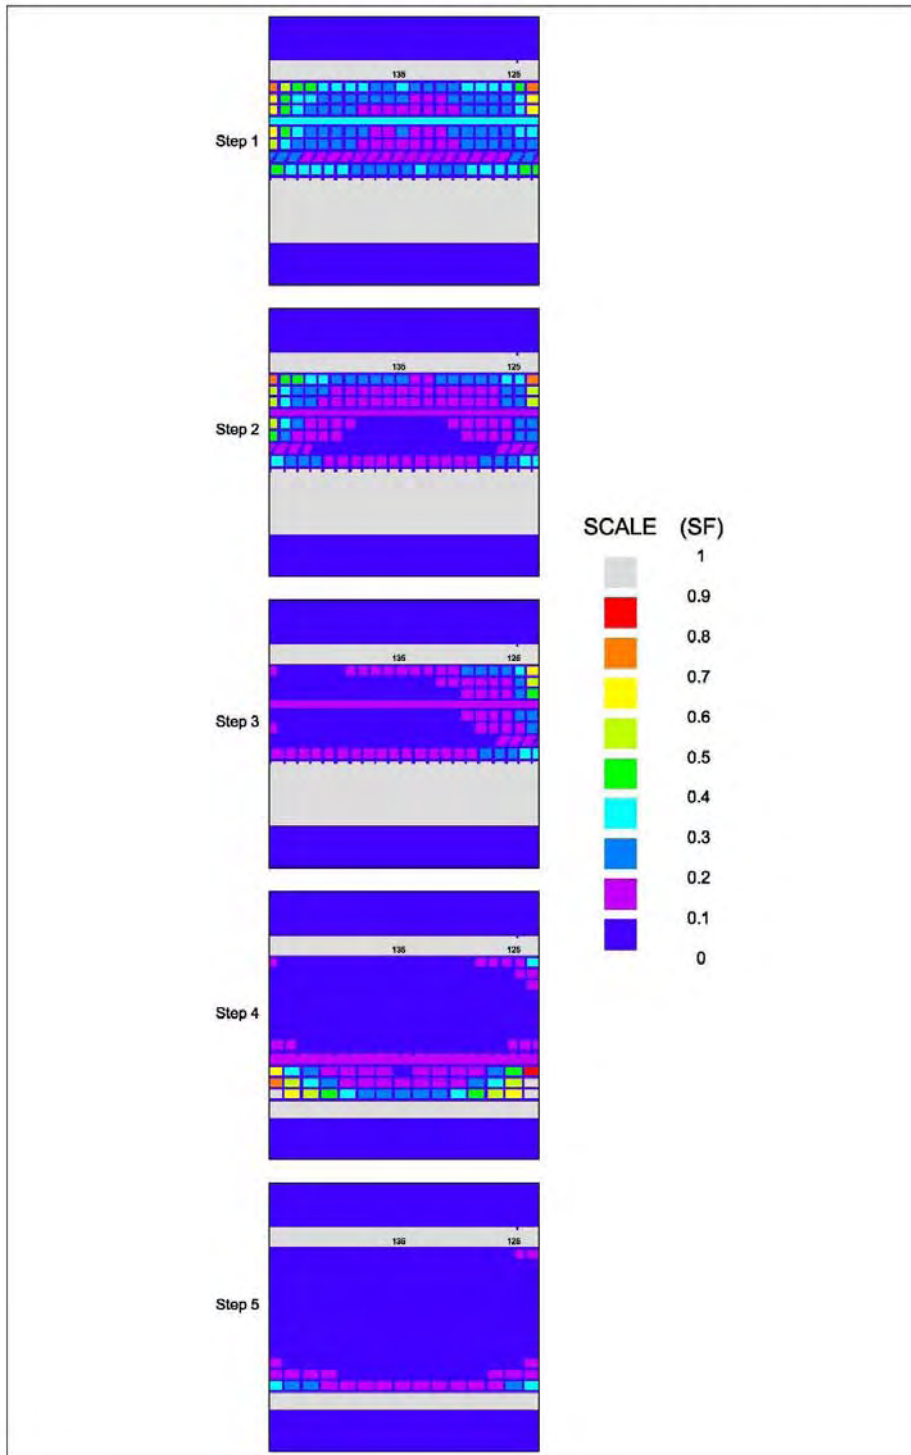
Figure 3.9-3 Five Step Damage Sequence – Pillar Strain SF (LaModel)

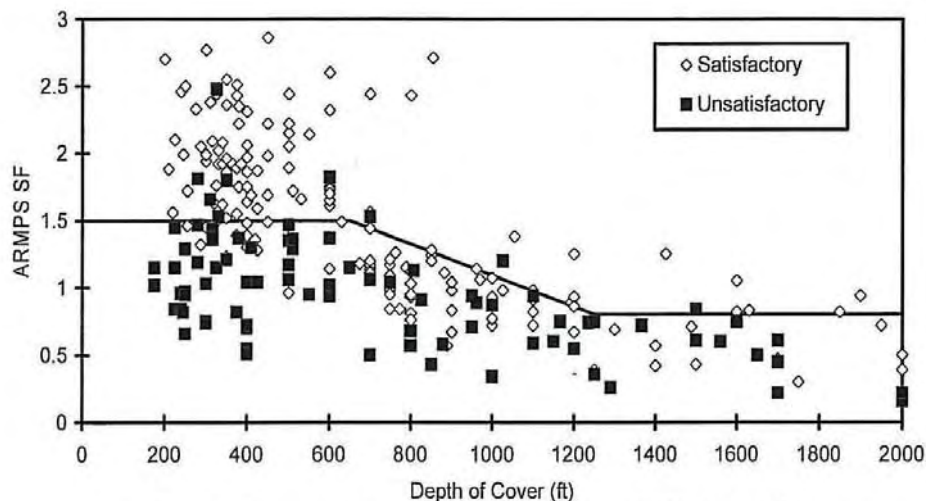
Figure 3.10-1 NIOSH ARMPs SF CHART GUIDELINE

The ARMPs case history data base collected by NIOSH, including deep cover cases, and showing the suggested pillar SF at various overburden depths.

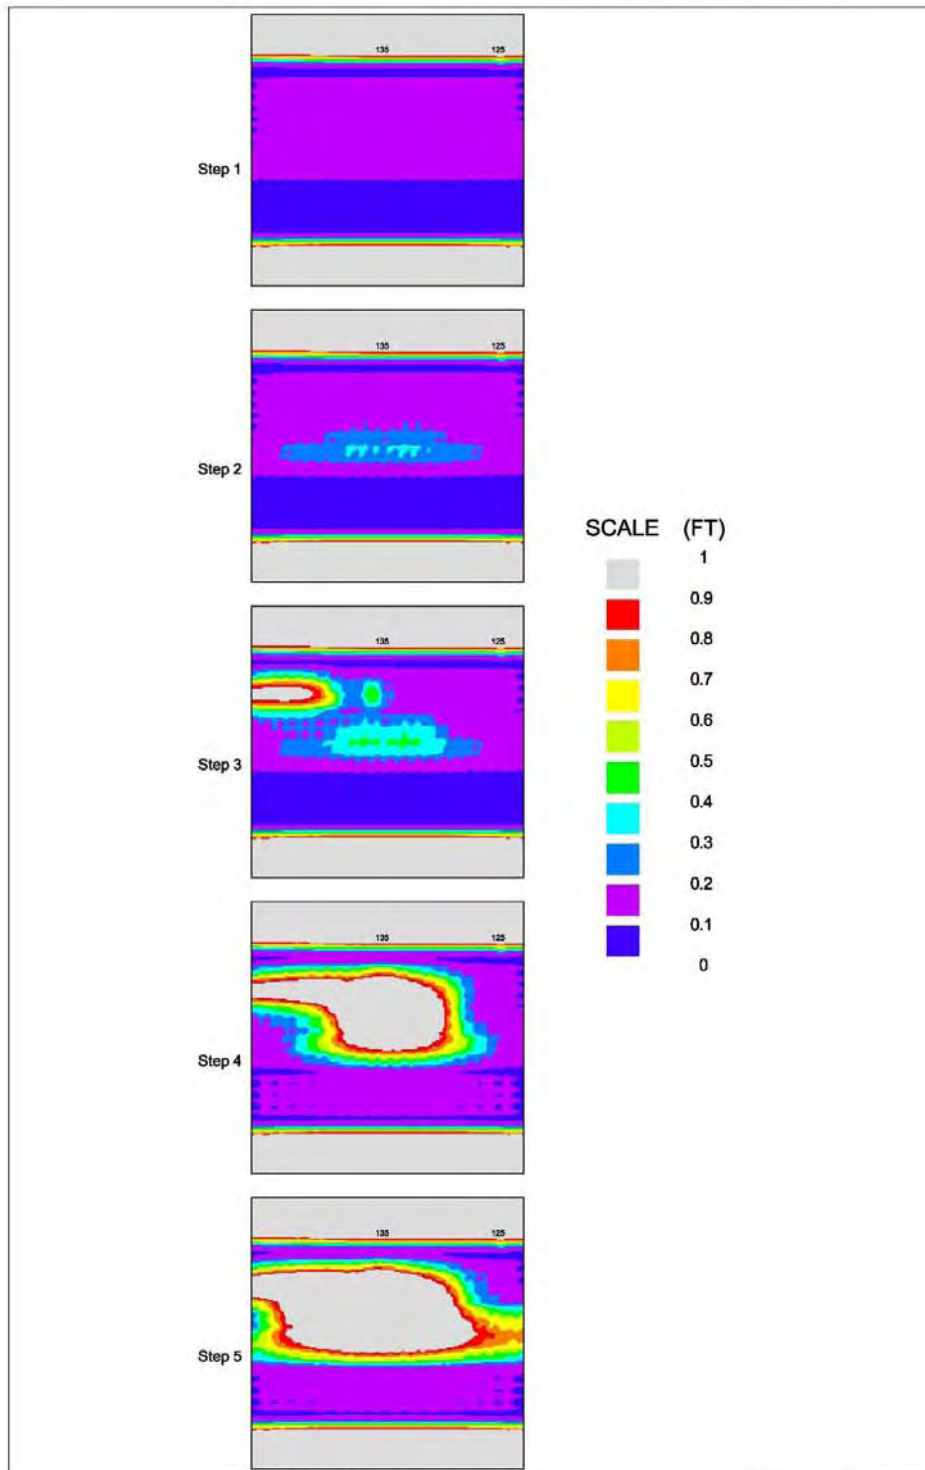
Figure 3.10-2 Five Step Sequence (1250 psi) – Seam Convergence (LaModel)

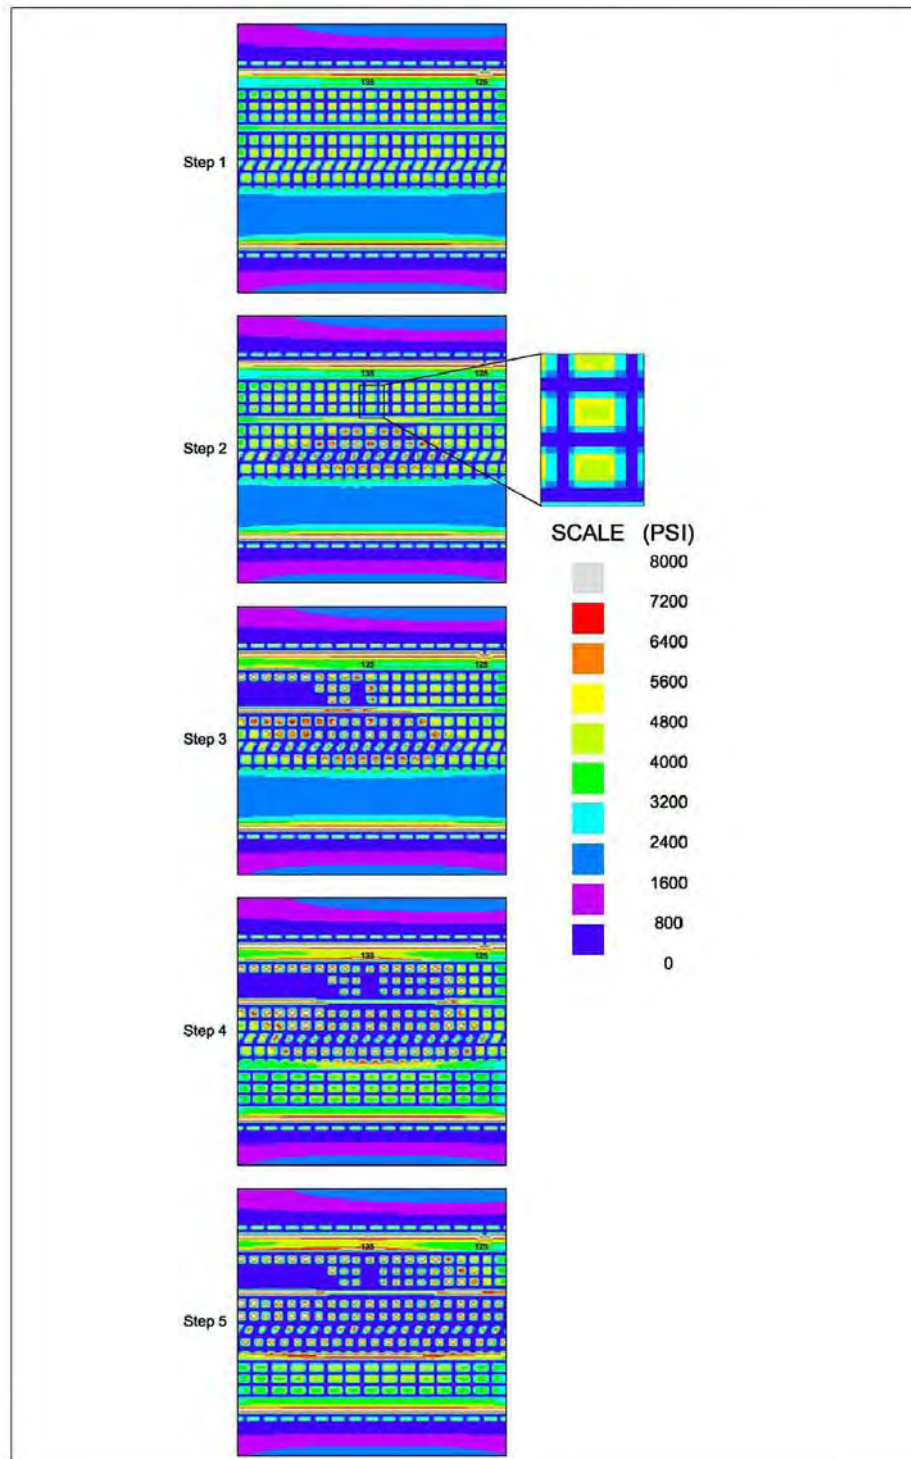
Figure 3.10-3 Five Step Sequence (1250 psi) – Vertical Stress (LaModel)

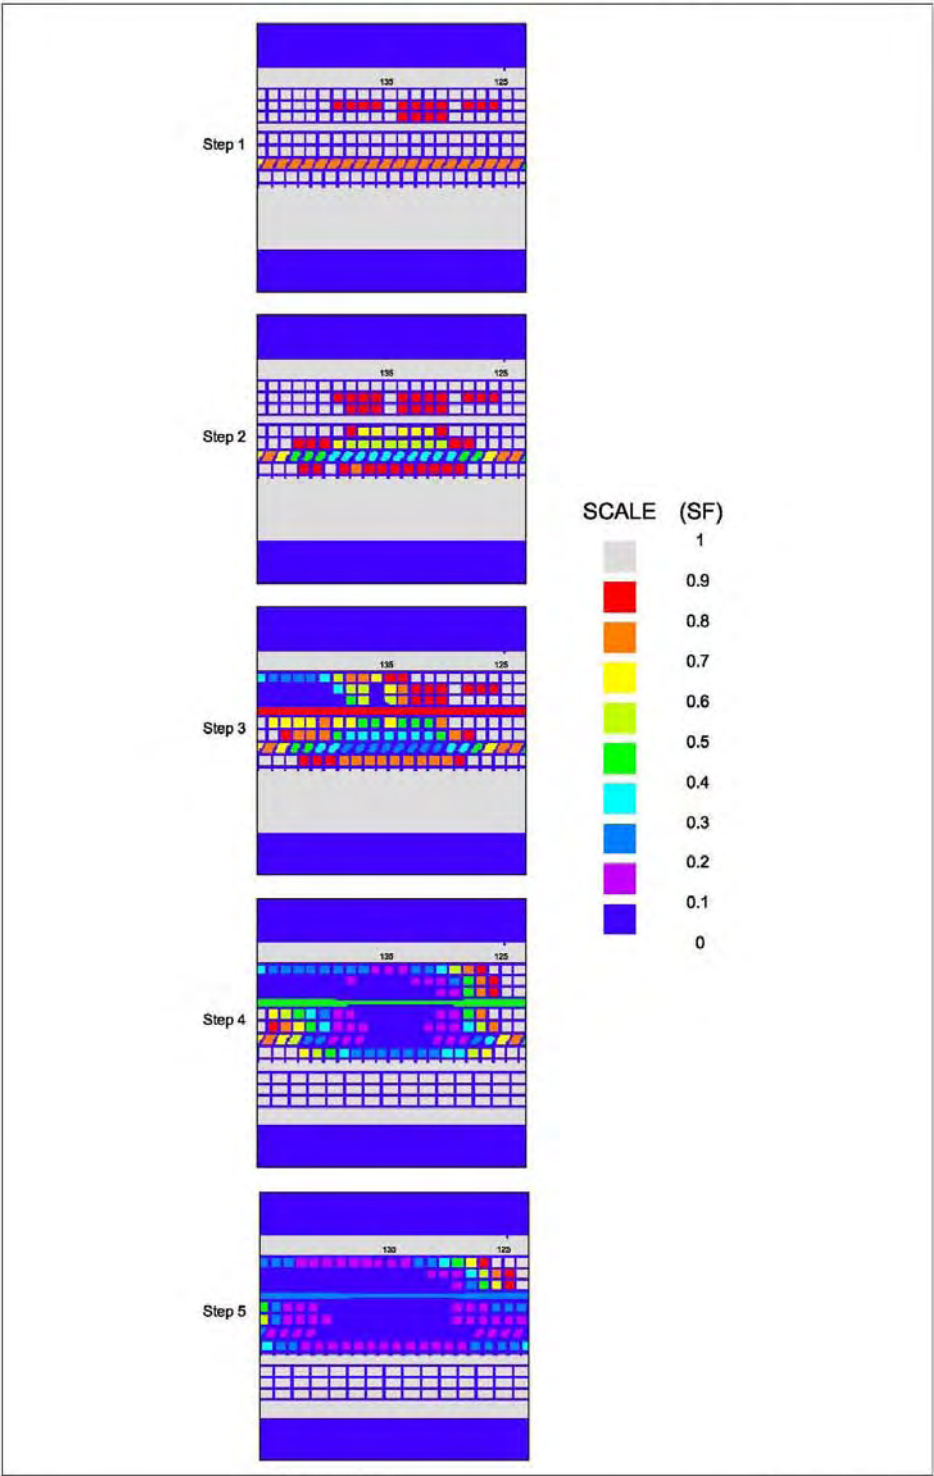
Figure 3.10-4 Five Step Sequence (1250 psi) – Pillar Strain SF (LaModel)

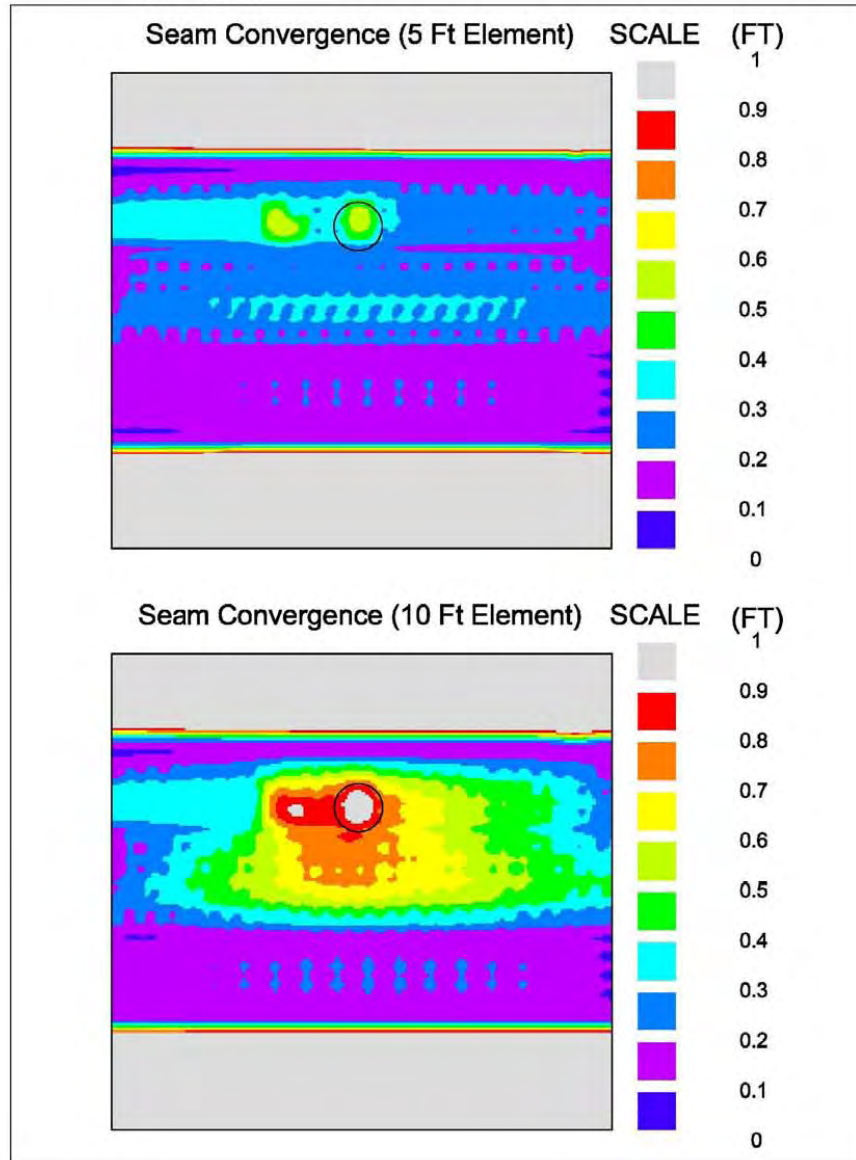
Figure 3.11-1 Element Size Comparison – Seam Convergence (LaModel)

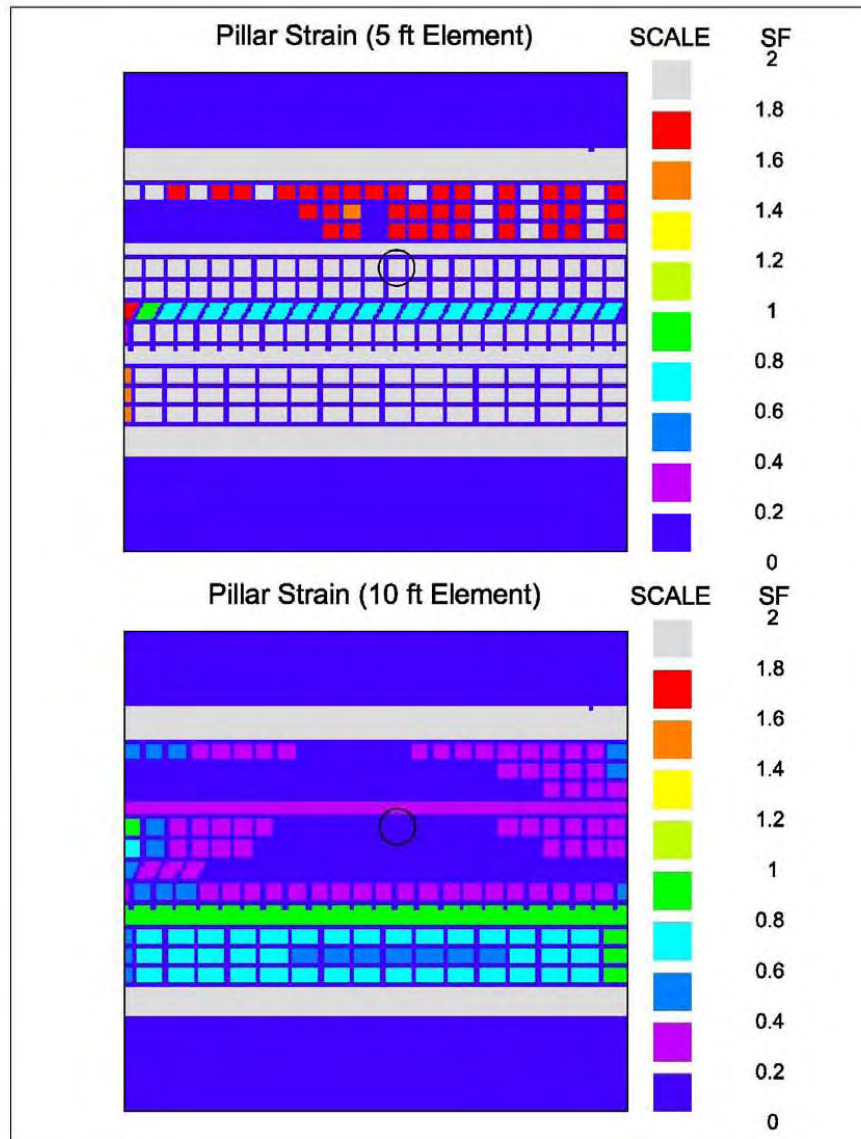
Figure 3.11-2 Element Size Comparison – Pillar Strain SF (LaModel)
